**Report on 1996 Migratory Fish Monitoring
in the Anacostia River Watershed, Maryland**

Interstate Commission on Potomac River Basin
Living Resources Section

Prepared for the U.S. Army Corps of Engineers
MIPR # E86960023
July, 1996

ICPRB Report #96-3

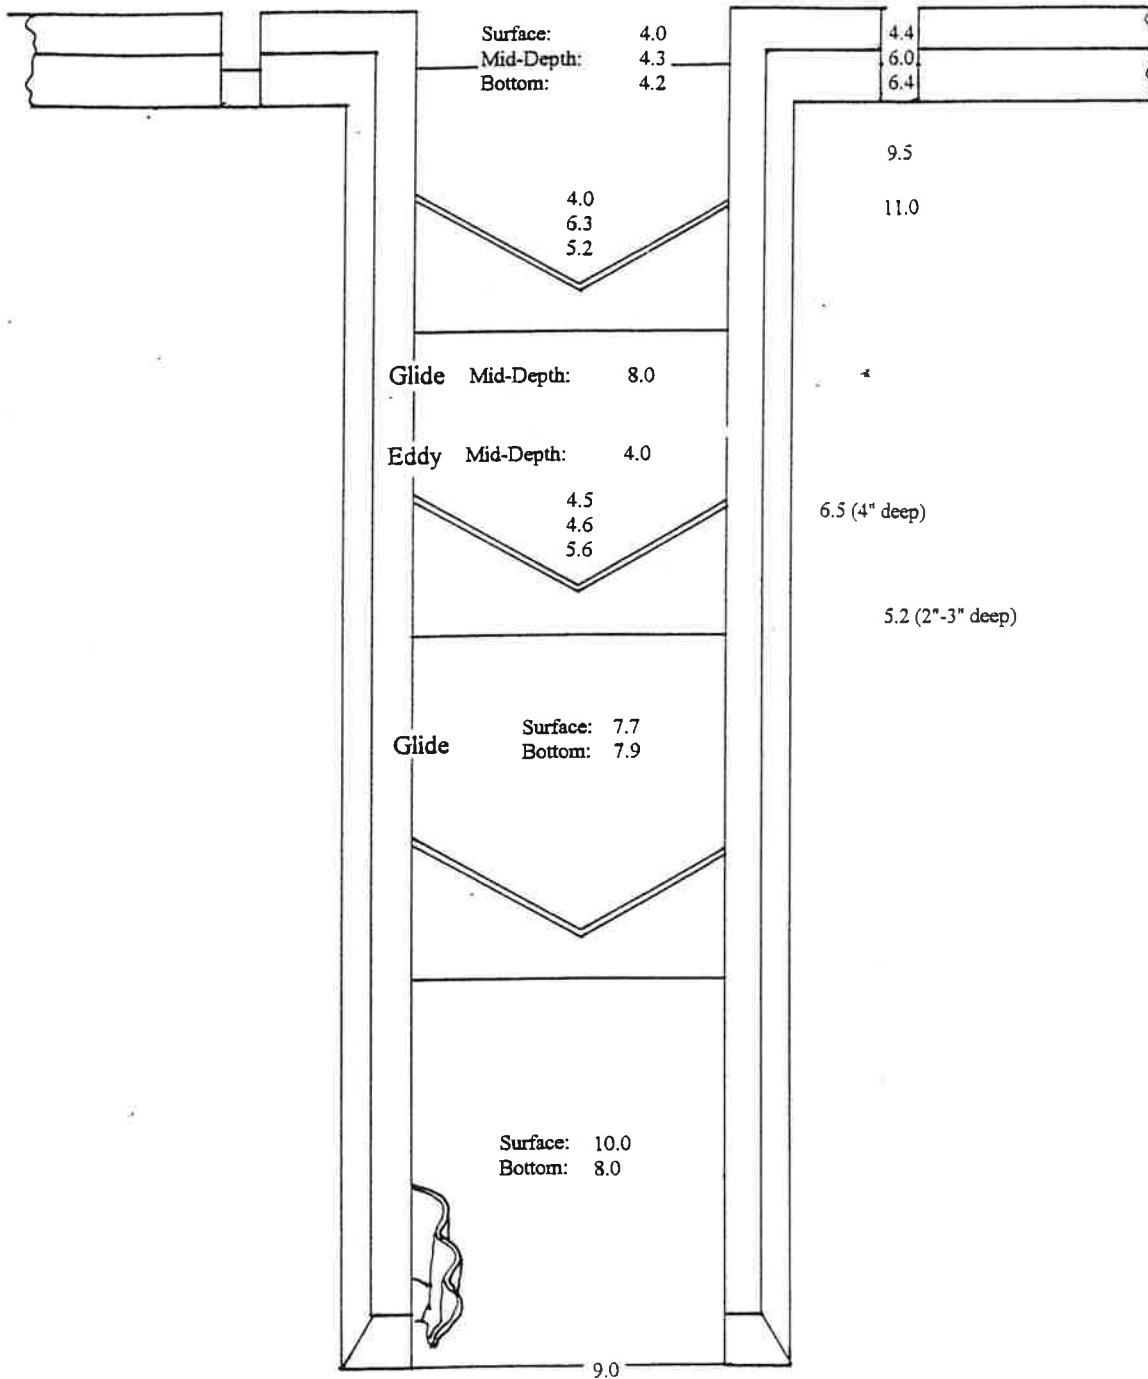
As this was the first year of operation for the new Denil fish Passage at Route 1, the appearance of the structure and the way fish reacted to it were carefully observed. On April 12, the first sampling visit, it was noted that the right half (looking downstream) of the lowermost baffle was absent. This had the effect of creating a very swift glide through the bottom third of the structure. Additional effects included a rapidly moving plume at the bottom of the passage and fairly strong eddy lines at medium to high flows.

A Marsh McBirney flow meter was used to assess some of the water velocities in the new fish passage structures. The Denil fish passage at MD Route 1 was monitored for flow speed on April 18, as it had been noted in the two previous samplings that something appeared to be wrong with the lowest "rung" on the fish ladder. The baffle/notch had been washed out and bent to the right side looking downstream. What should have been a slow cell of water had turned into a rapid glide. Figure 5 shows that the water velocities increase from the weir to the foot of the Denil.

Note: All velocity measurements taken 04/18/96. All water velocity values reported are in feet per second. Additional measurements were taken in the plume leaving the bottom of the chute. Water velocity was measured as 9.0 at the foot of the structure. 4 feet below the structure, the mid-depth water velocity was 7.2. 8 feet below, the mid-depth water velocity was 8.8 and 12 feet below, it was 6.2.

2) During the course of this project, we contacted the U.S.A.C.E. Baltimore District to relate what appeared to be damage to the weirs in the Northwest Branch Denil ladder. The Corps responded and fixed the downstream weir during the week of August 5, 1996. The Corps has indicated that one other weir within the structure appears to be damaged and that the Prince Georges County has agreed to fix it as part of routine maintenance. We extend our gratitude to the Corps for responding to the problem. We also recommend that stronger baffle materials and/or stronger attachment devices be investigated for this structure.
