# **ANACOSTIA TRASH TMDL-RELATED BASELINE CONDITIONS MONITORING IN MONTGOMERY AND PRINCE GEORGE'S COUNTY**

**Prepared by  
Jan Ducnuigeen  
Interstate Commission on the Potomac River Basin**

**The Metropolitan Washington Council of Governments**

**ICPRB Report Number: ICPRB-09-02**

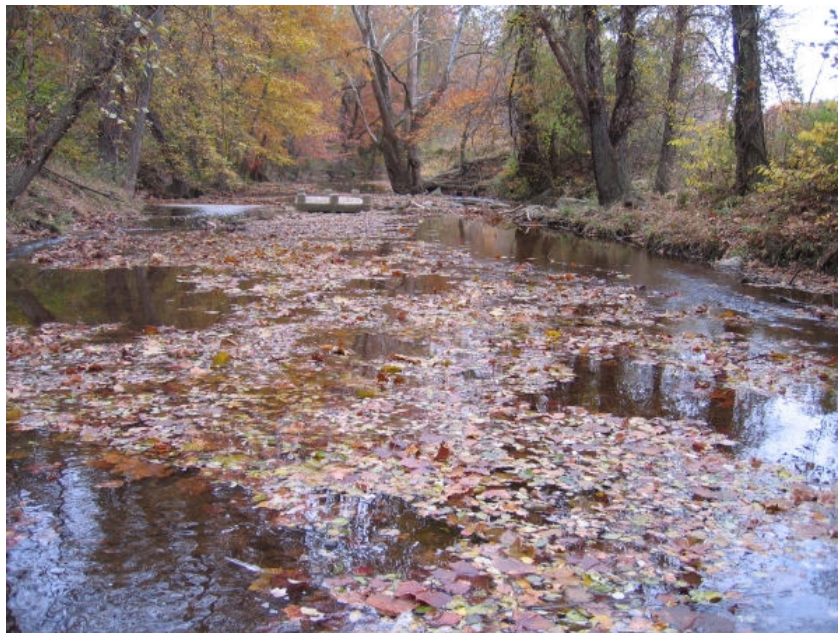
Surveys were not conducted between October and mid December 2008 due to the high volume of fallen leaves inundating the stream channels and obscuring the enumeration of trash items. Figure 3 provides an example of the conditions during those times impacted by fallen leaf cover.

Figure 3. Leaf cover in November obscuring stream bottom and impacting trash enumeration.

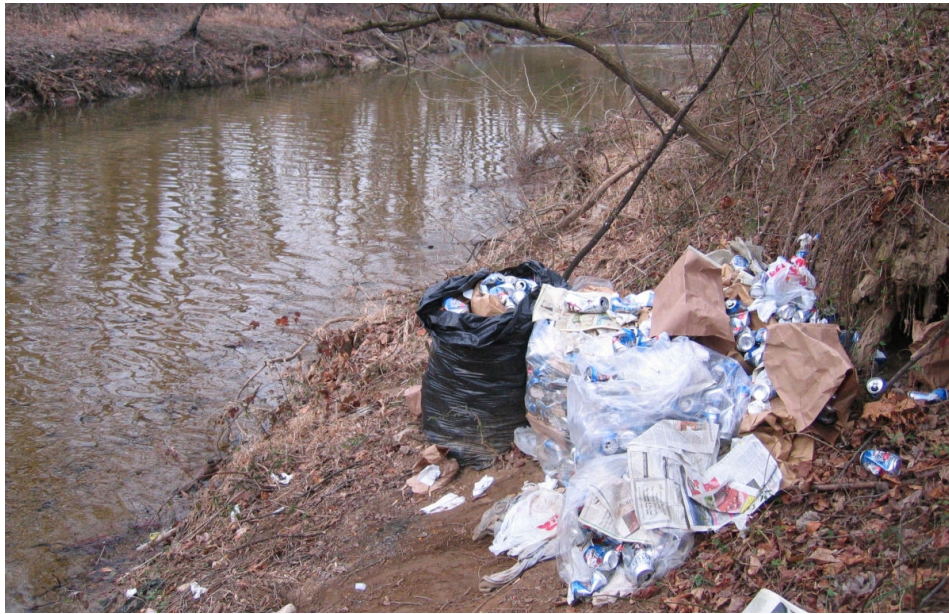
Figure 4. Evidence of deliberate dumping of cans and newspapers on Paint Branch at Route 1 (05-001).

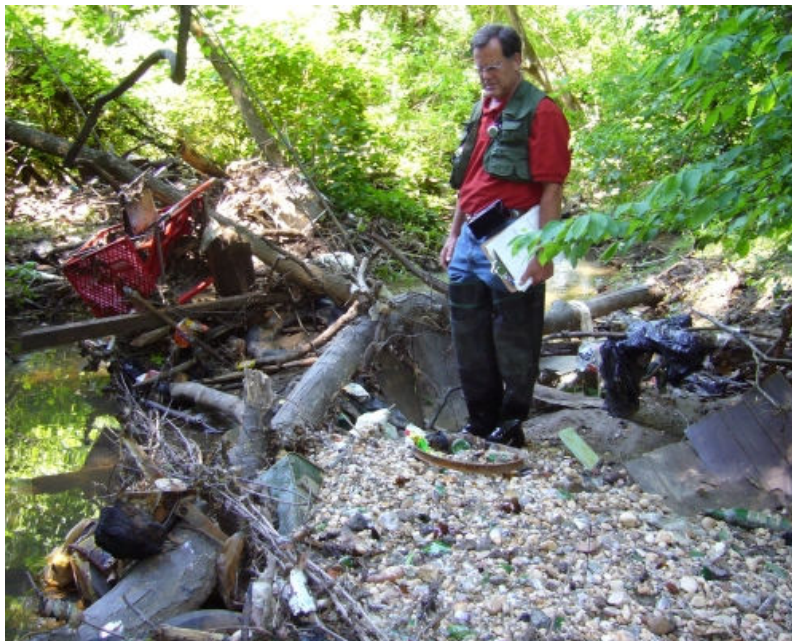
Figure 5. Large volumes of trash on Watts Branch at Bugler Street (22-003) in spring 2008 before changes were made to the riparian corridor. The foreground gravel bar has significant broken glass pieces.

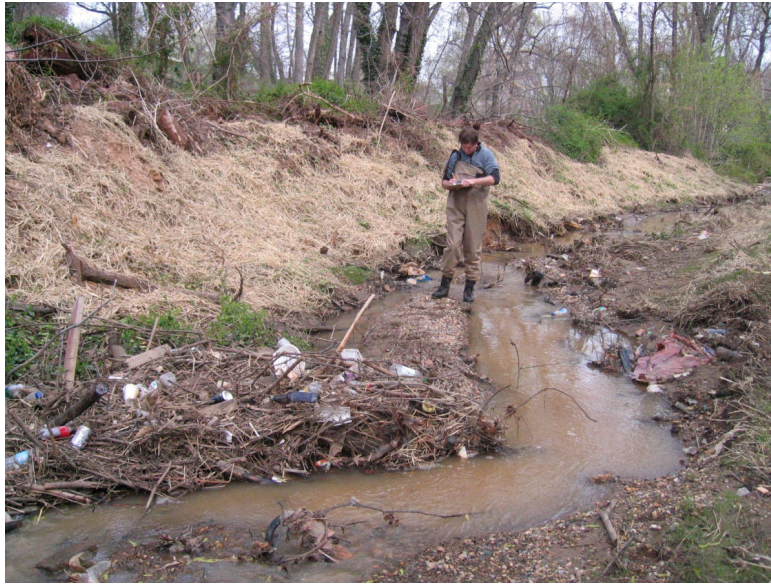
Figure 6. Large volumes of trash on Watts Branch at Bugler Street (22-003) in spring 2009 after changes were made to the riparian corridor.

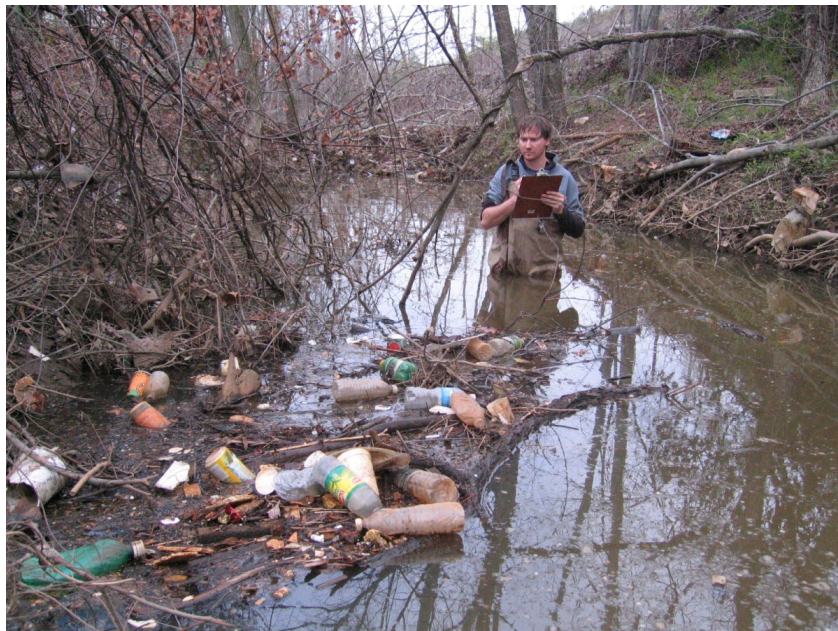
Beaverdam Creek at the New Carrollton metro site also showed significant changes between 2008 and 2009. In the spring of 2008 much of the stream survey reach existed as a shallow 6-9 foot wide, less than 1 foot deep channel. In the latter portion of 2008 and into 2009, beaver activity increased, trees were felled, and several beaver dams were created in the stream. In addition, clear cutting of trees by the railroad maintenance crews on the riparian area next to the neighboring train tracks led to increased numbers of tree debris in the stream channel. Both of these activities increased the depth and width of the stream (Figure 7). Turbidity of the water remained high, even weeks after the last major rainfall. As a result, less trash could be observed and thus enumerated in the deep portions of the stream channel in 2009.

Figure 7. Deep portion of Beaverdam Creek at the New Carrollton metro (19-040A) after Beaver activity and railroad right-of-way tree clear cutting.

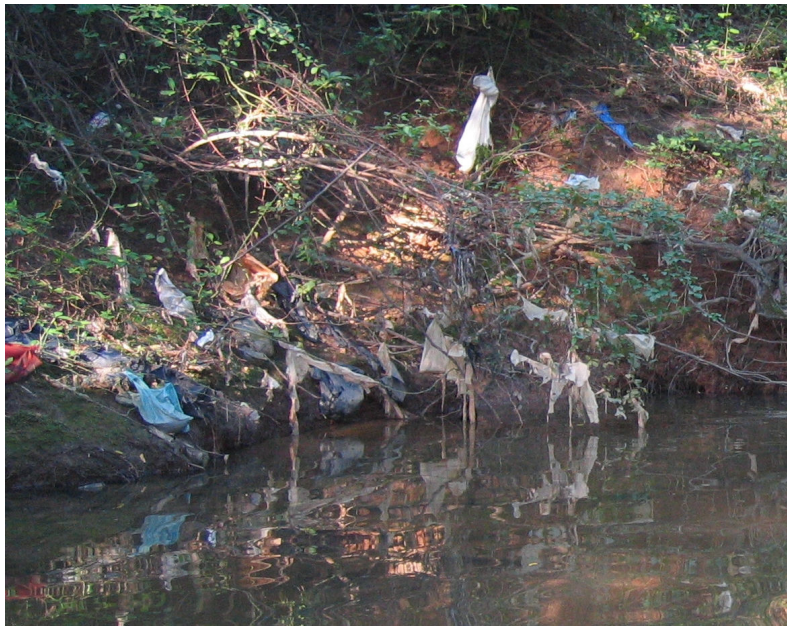
This baseline trash survey of the Anacostia watershed revealed plastic bags representing the single most dominant type of trash in nearly all stream reaches. Plastic bags are often found attached to “strainers”, over-hanging trees or other objects in the water (Figure 8). Survey sites containing fewer strainers also seemed to trap fewer plastic bags. During times of high water flow, these plastic bags are often deposited in over hanging trees and limbs, producing a very trash scarred river bank landscape after the water levels drop.

Figure 8. Example of plastic bags hanging on strainers and other objects caught at higher water levels.

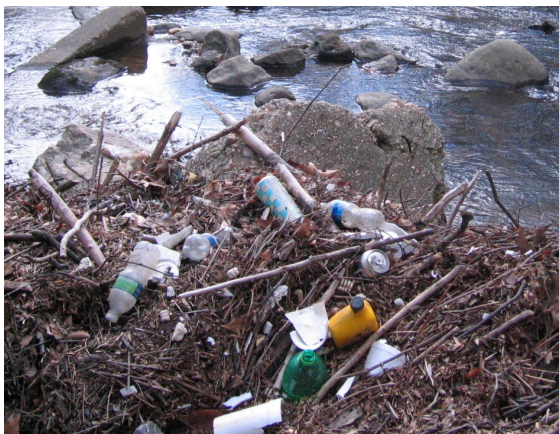
Figure 9. View of small white pieces of styrofoam trash commonly found in streams

Another one of the most common types of trash was styrofoam. This type of trash is most commonly found in the form of cups, fast food serving containers, or food coolers. Within the stream, these styrofoam trash items are usually in very small pieces, rather than whole cups, containers or coolers (Figure 9), due to the fragile nature of this type of material. Counts of individual pieces of styrofoam can therefore be very high within a site survey. The lightweight and buoyant nature of the styrofoam also causes this type of trash to be carried long distances downstream during storms.

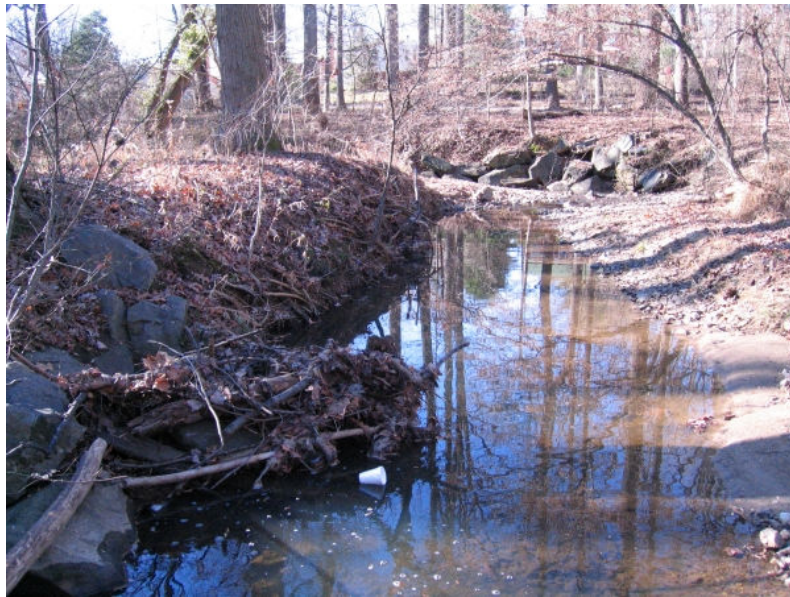
SCSC204: View looking downstream at trash strainer and Styrofoam from middle of survey reach.

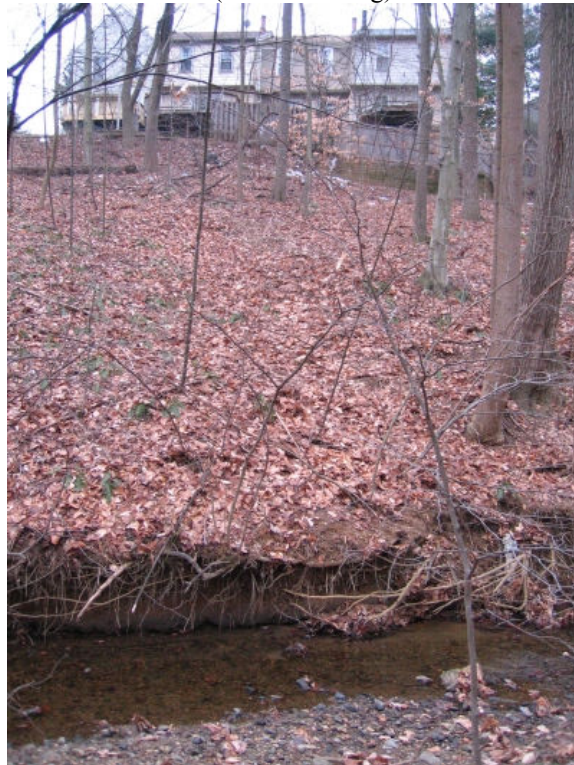
LPLP109: View of household trash thrown over residential fences (top of photo) approx 30ft from stream banks.

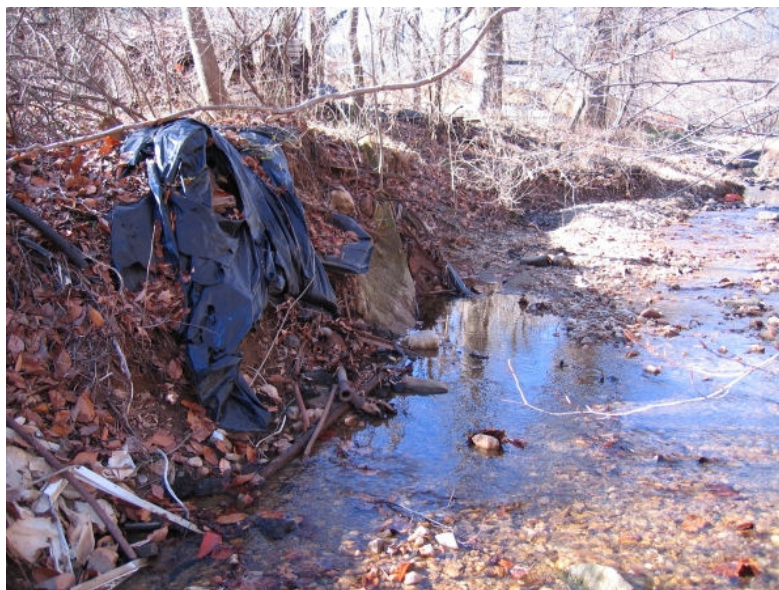
NWBP301: View looking upstream at trash and landfill debris
