INTERSTATE COMMISSION ON THE POTOMAC RIVER BASIN

# **POTOMAC RIVER BASIN WATER QUALITY 82-83**

**ICPRB Publication 85/1**

**July 1985**

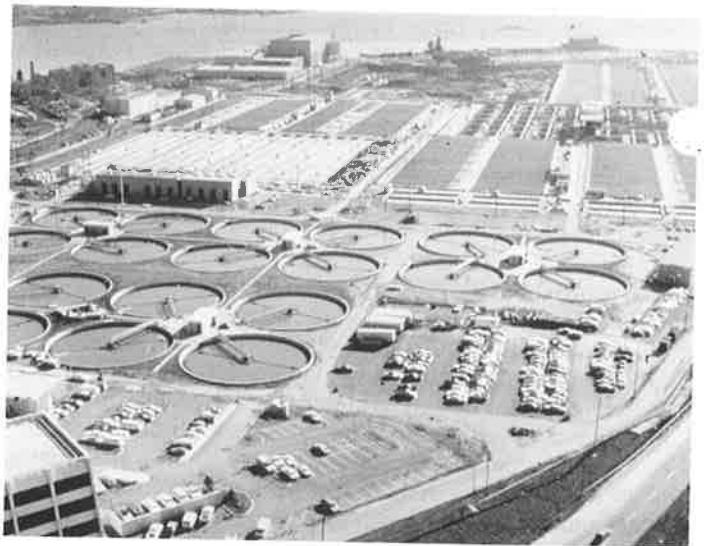
The Blue Plains regional wastewater treatment plant is the basin's largest point source.

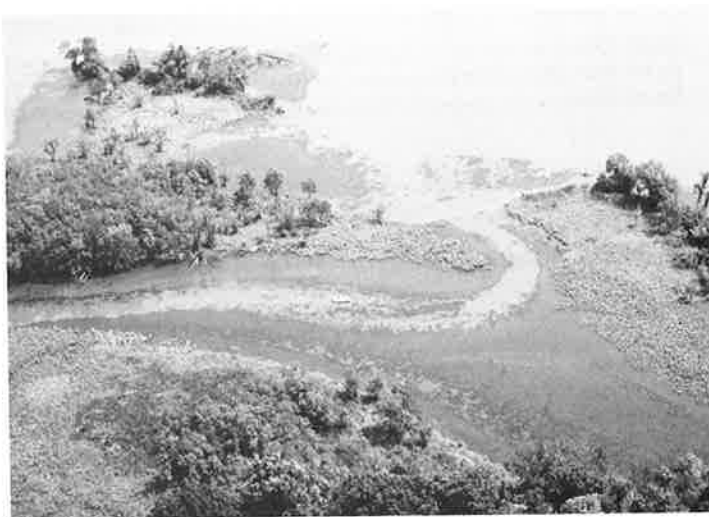
Many types of submerged aquatic vegetation are growing in the Potomac River, including *Hydrilla*, shown here in Dyke Marsh below Washington. Photo: D. Loveland

The reappearance of submerged aquatic plants was not all good news. *Hydrilla verticillata*, one of the species that has become widely distributed along the Potomac, can be a nuisance plant. *Hydrilla* is a very aggressive, quick growing, competitive plant. It is able to reproduce in five different ways, and it can crowd out desirable plants. Consequently, it has the potential to cause problems for navigation and recreation.

*Hydrilla* was first found on the Potomac in 1981 in Dyke Marsh, a wetland on the Virginia shore 1.5 miles south of Alexandria. During 1982, the area covered by *Hydrilla* increased within Dyke Marsh, but there were no reports of *Hydrilla* in other locations. The infestation of the plant at Dyke Marsh became very thick during 1983, and the plant began to spread to other places along the river. In most instances, the *Hydrilla* found outside of Dyke Marsh occurred amid patches of more desirable native aquatic species.
