Potomac River Expedition '87 Report
Interstate Commission on the
Potomac River Basin

ICPRB Report 87-5

Potomac River Expedition '87 Report

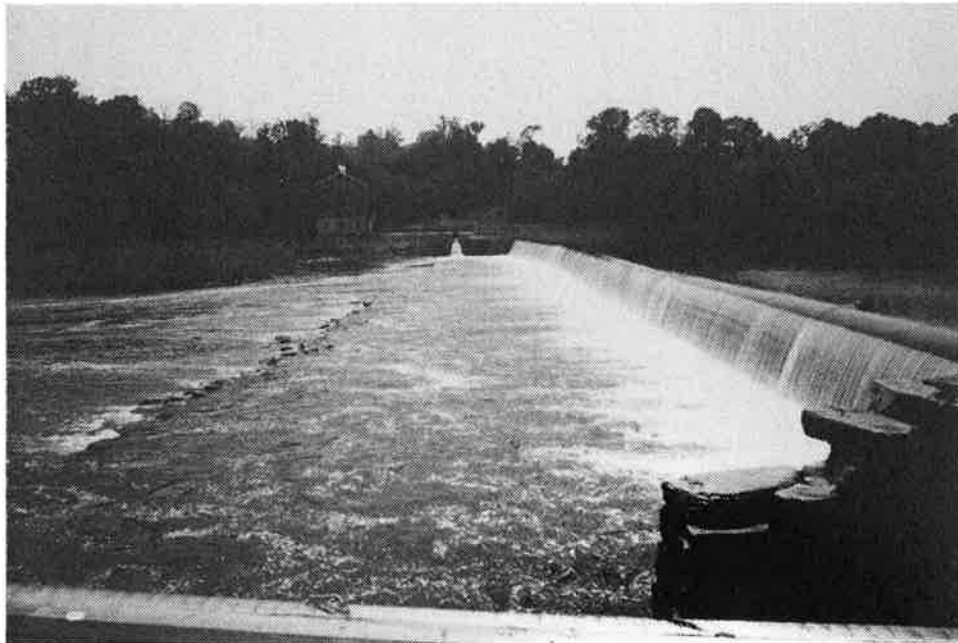
Dam No. 4

The river is straddled by several dams, which create large slackwater areas behind them, changing the character of the river. The slackwaters are havens for motor boating and other recreation, and also are the sites for most residential development. Technology has formed the character of the present-day Potomac in another way. The combination of the canal park on one side of the river and the railroad right-of-way on the other has left sections of the river surrounded by a protected ribbon park or buffer strip. This concept has been used in designing other parks in the metropolitan area, and was a recommendation of the President's Council on Americans Outdoors. In other areas, the canal is complemented by a steep

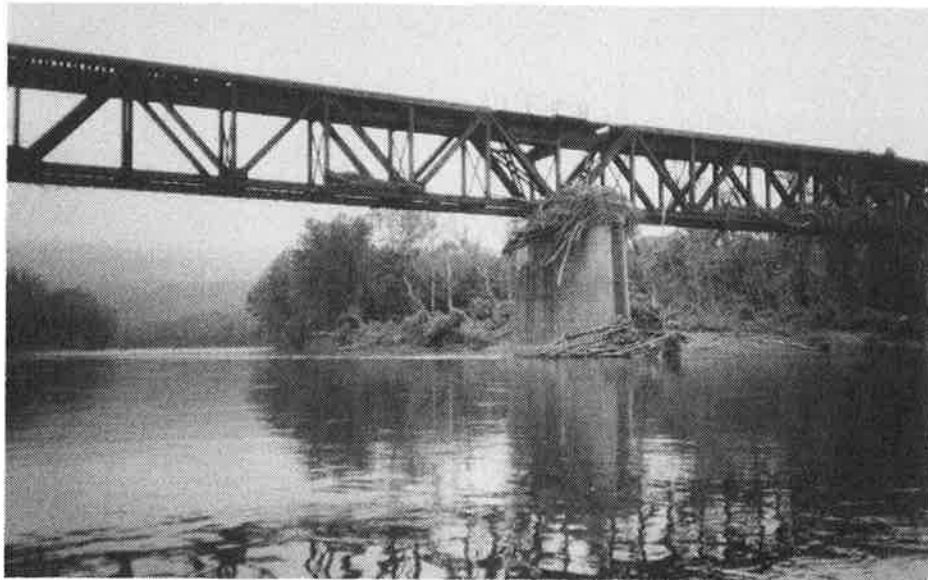
Flood Debris in Paw Paw Bends

The extent of visible damage almost two years after the November 1985 flood surprised some team members. Evidence of the flood was apparent from near Cumberland, especially in large trees and other debris trapped high in bridges, and large downed trees on the shore and in the river. Many of the felled trees were struggling to put out new foliage. Damage was most apparent at the confluence of the North and South branches (the South Branch sustained the heaviest flows in the Potomac basin). Damage was less visible downstream of the confluence with the Shenandoah River at Harpers Ferry, W.Va.

Other observed flood debris included cars and trucks, parts of house trailers, and other collected large items on the shore and in the shallows.

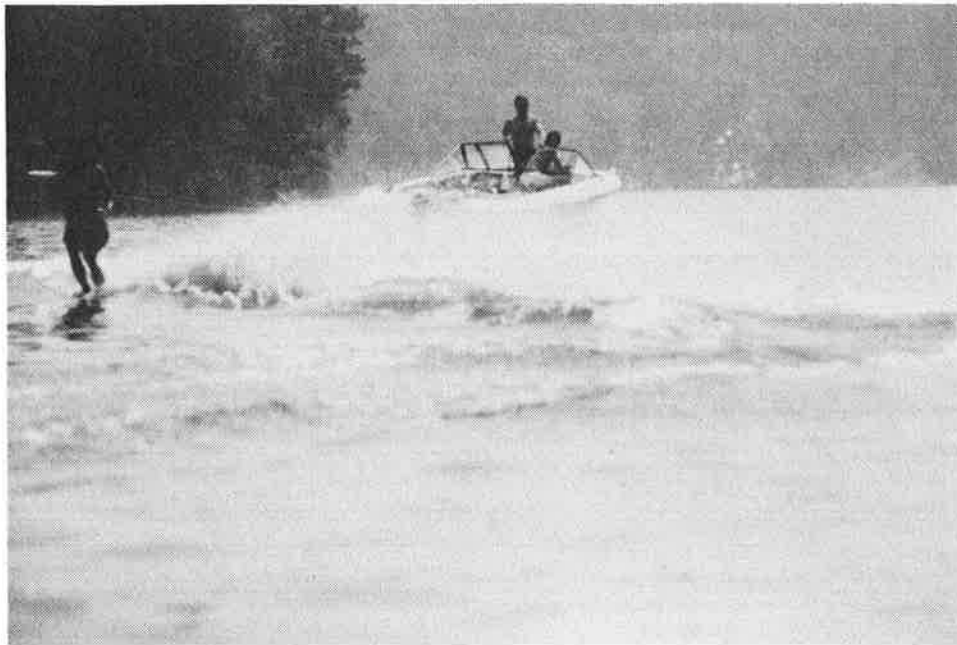
Recreation Behind Dam No. 5

Downstream, the river becomes larger, with greater access opportunities. The ski boats, while annoying to canoeists and fishermen, were suited to the wide, flatwater areas in which they were found. Most of the river was heavily used on weekends, with fair use even in the upper portion. Fishing from boats and the shore was observed much of the time.
