PHASE 1 - EVALUATION OF TRAVILAH QUARRY FOR WATER SUPPLY STORAGE

Final Report

Interstate Commission on the Potomac River Basin (ICPRB)

3 OCTOBER 2014

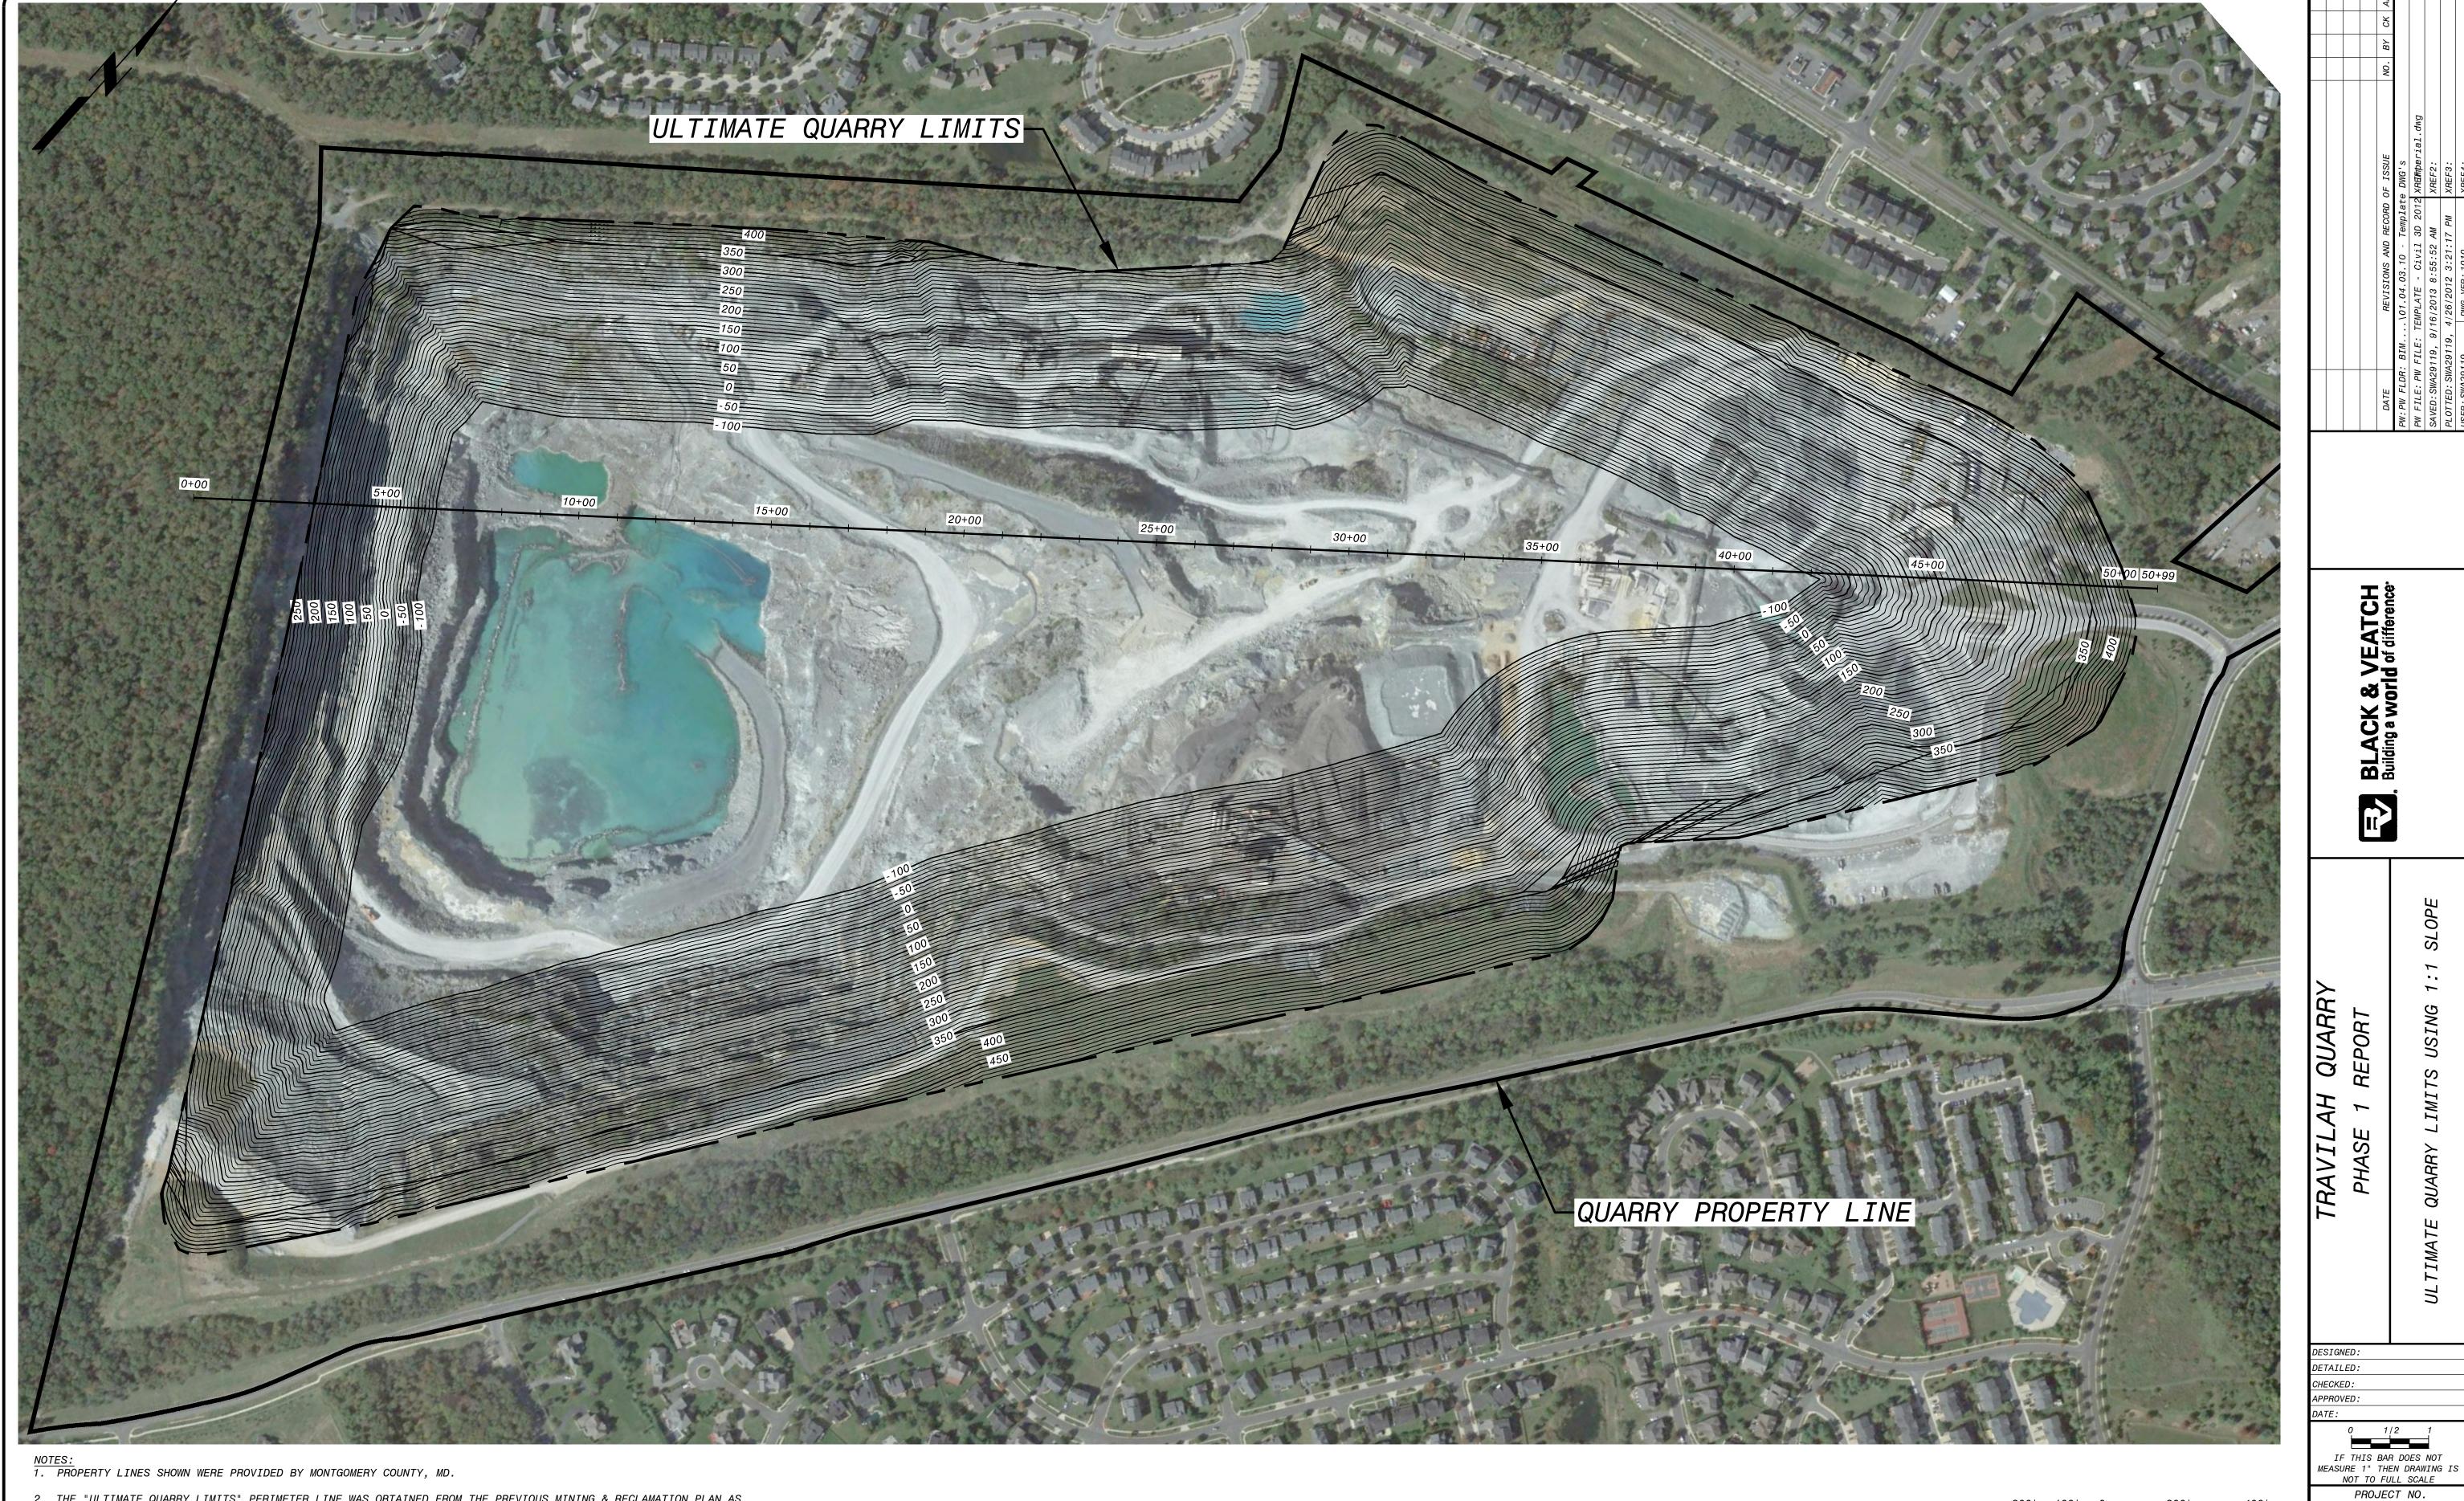
182811 FIGURE 3-3

2. THE "ULTIMATE QUARRY LIMITS" PERIMETER LINE WAS OBTAINED FROM THE PREVIOUS MINING & RECLAMATION PLAN AS DEVELOPED BY RODGERS AND ASSOCIATES DATED 1982 TO 2006.

4. CONTOUR ELEVATIONS ARE A HYPOTHETICAL SLOPE OF 1:1 WHICH IS EQUIVALENT TO 50 FT HIGH AND 50 FT WIDE BENCHES.

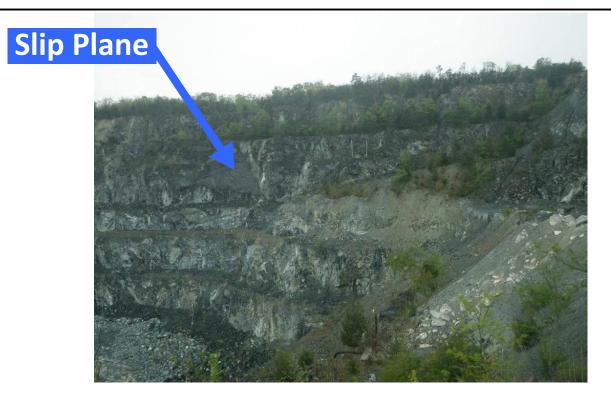
Slip Plane on NW/SE Quarry Wall

The historic highwall presents the main stability issues in the quarry. Historic planar failure has occurred in the past as evidenced by the relatively large slip surface striking N-NW dipping 50 into the excavation as observed in the quarry highwall (Figure 4-3). Wedge failure has also occurred, possibly even recently, along the historic highwall to the northeast by the Crusher Plant where the joint set striking N-NW with relatively high-angle joints dipping in opposite directions coincide with a steep backwall dipping into the excavation. The two opposite dipping joints form a rock wedge and over time allow the rock wedge without back restraint to fall or drop. Given the severe blast damage to the rock walls, and the relatively uncontrolled vertical height of the historic highwall, this degradation is to be expected and some continued raveling along the historic highwall exhibiting adverse joint patterns is to be expected over time without mitigating measures. The current bench excavation minimizes the effect of rock drop-outs. The general tendency appears to be rock toppling/sliding off the bench from joints dipping into the excavation, but this failure while filling one void, opens another, and is generally a movement towards stability much like soil reaching its angle of repose. Shear zones, mylonitic joint filling, talc, chlorite, and slickensides all contribute to instability and significantly reduce joint cohesion. Current highwalls that are at their limits do not indicate that a significant stability issue is present; however, additional mapping and evaluation is recommended as the quarry nears its ultimate excavation limit.

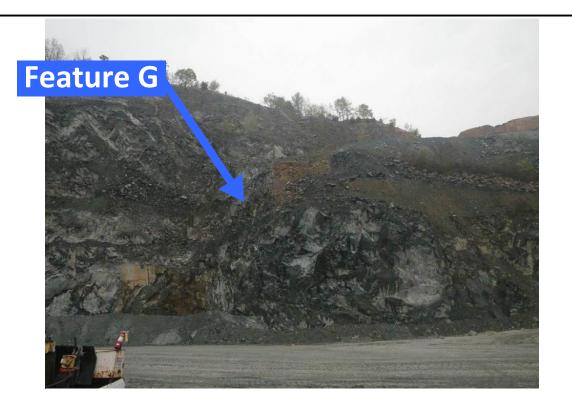
Feature G Observed Crossing Through Quarry

Adverse jointing has led to some rock falls in the historic highwalls primarily on the northwest wall of the quarry (see Figure 4-3). This issue has been remediated by benching the excavation in recent years. During the site visit, two series of quarry operations were noted: the first, the historic quarry cut vertical highwalls estimated to be 75 ft to 125 ft high at the northwest quarry limits above the sump, and the second quarry excavation phase with benches estimated to be 50 to 75 ft high. There appear to have been a few fallouts of rock blocks at various locations and one large slip-plane area was mapped, approximately 35 by 50 ft wide (estimated from a distance) at the northern end of the old highwall area along the southwest wall (see Figure 4-3). As it was understood during the site reconnaissance, the old highwalls were excavated starting around 50 years ago and ending somewhere around 25 years ago before benching was initiated. Four major and persistent discontinuities were noted along the southwest quarry highwall; three striking roughly NE/SW dipping at angles estimated at 65, 50 and 80 degrees from horizontal, and one striking roughly E/W dipping at an estimated angle of 50 degrees to the north. The discontinuity/dike described as Feature "G" in the previous reports was observed in the southwest highwall cutting roughly NE-SW through the quarry (see Figure 4-3).

Two of the borings should be drilled at a 20 degree angle from vertical through Feature G along the perimeter rim of the SW quarry wall to characterize the location and thickness of the feature and to test the permeability of this feature. An additional vertical boring should be drilled along the SW wall closer to the location of the slip-plane failure present in the quarry. Two borings, one inclined at 20 degrees from vertical and the other vertical should be drilled along the perimeter of the northwest wall and two borings should be drilled along the southeast wall (one vertical and one inclined 20 degrees from vertical). The final boring is recommended at the north end of the quarry. This boring should be located in an attempt to intersect Feature G north of the quarry.

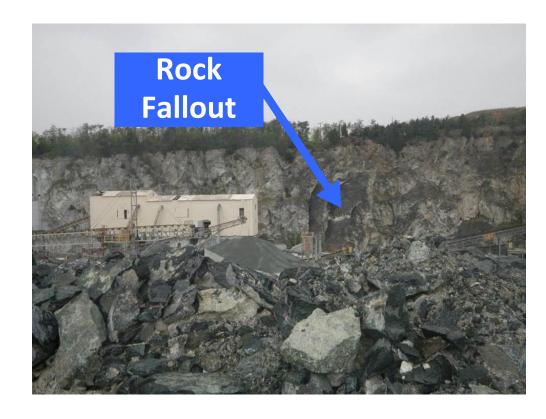
Rock Block Fallouts Along NE Highwall

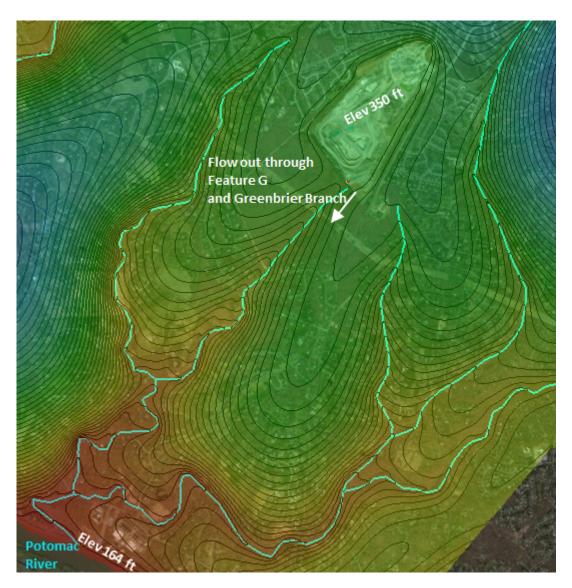
Figure 5-3 Simple Groundwater Flow Model Results, Adding Water to Quarry to Maintain Elevation 350 feet MSL

of 350 ft MSL could be maintained with minimal exfiltration. Further refinement of the model is required as additional hydrogeological data is collected to validate this prediction.

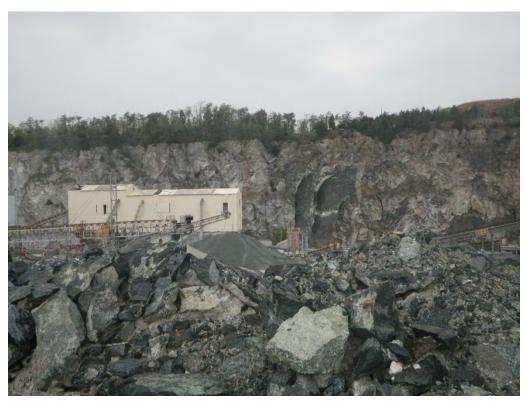
NW highwall with rock wedge (dogtooth) failures along joints in back wall.

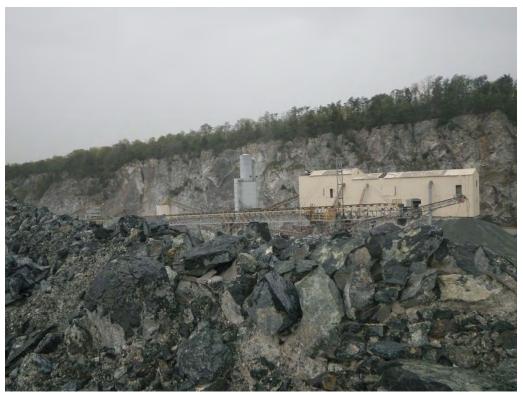
NW highwall looking SW.

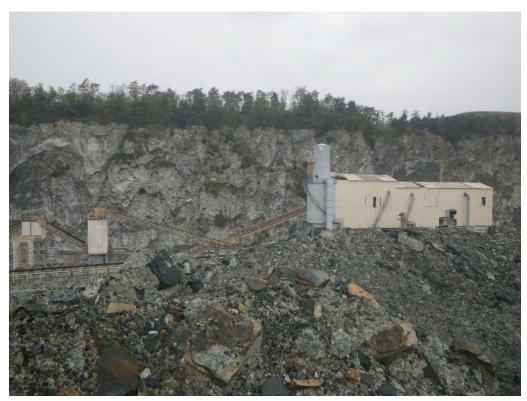
NW highwall with rock wedge failures visible.

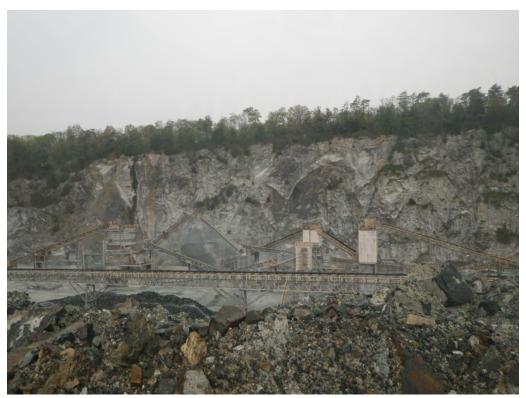
NW highwall, minimal soil cover present above rock. Black staining from surface water flow.

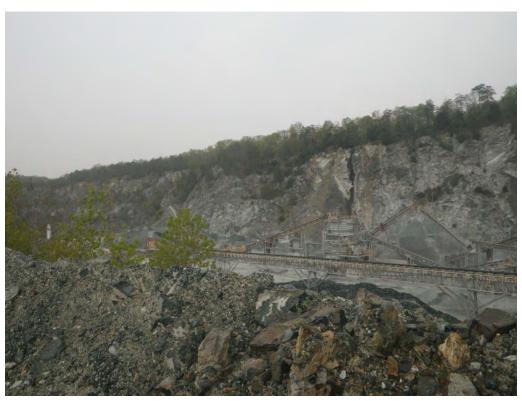
NW highwall behind rock conveyor. Black staining from surface water flow.

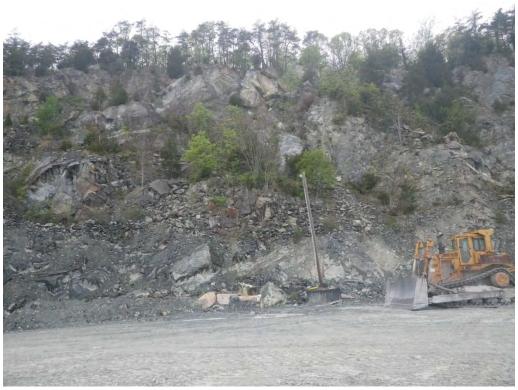
Southern end of NW highwall. Undefined rock benches with blast damage induced rock falls.

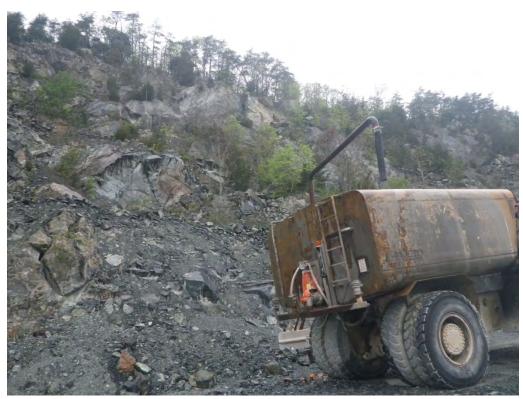
Typical blast damaged highwalls.

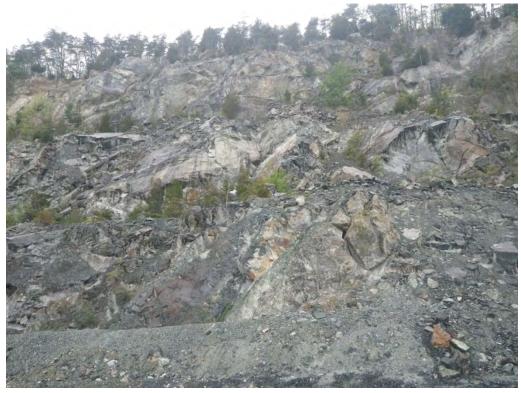
Blast damaged southern end of NW highwall.

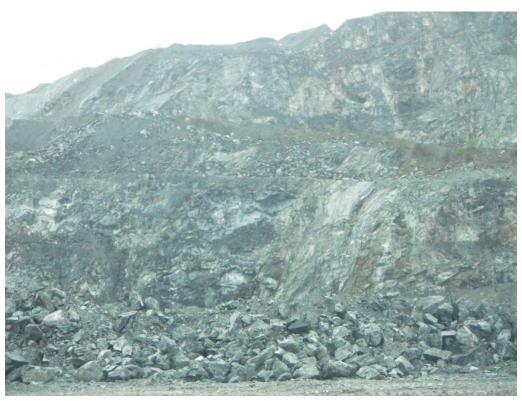
NE highwall. Blast damage evident.
