*Stressor Analysis Report for the  
Benthic Macroinvertebrate Impairments  
in the Accotink Creek Watershed,  
Fairfax County, Virginia*

**Prepared for  
Virginia Department of Environmental Quality**

**Prepared by  
Interstate Commission on the Potomac River Basin**

**Revised June 21, 2017**

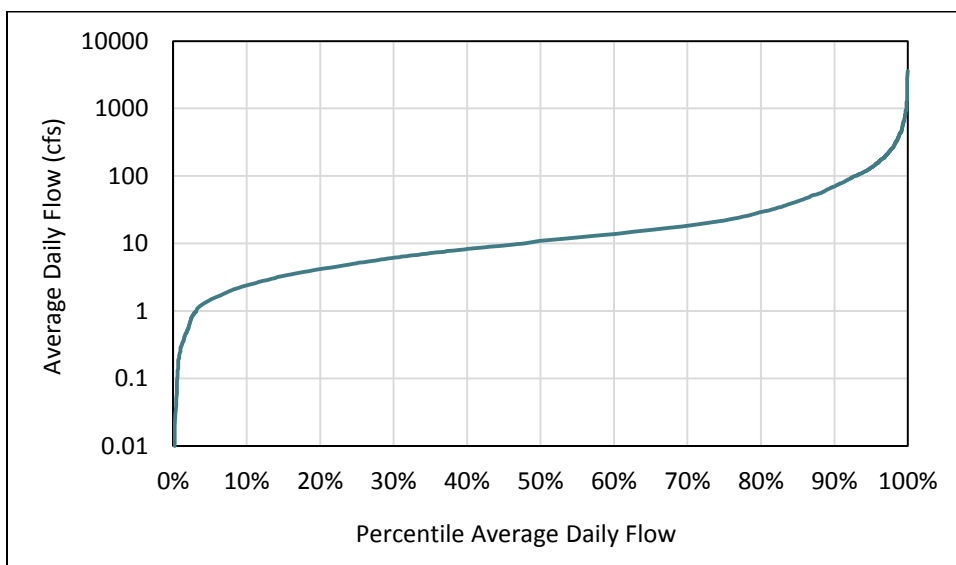
**Figure 3-9: Average Daily Flow, Accotink Creek near Annandale, VA, 1990-2014**

**Figure 3-9** shows the distribution of daily average flows at the gage on Accotink Creek near Annandale. The percentile flow of average daily flows from this gage was used to construct an index of daily hydrological conditions for the Accotink Creek watershed as a whole. Storm conditions generally occur at 90th or greater flow percentiles. The boundary between ambient and storm conditions is approximate, however, and small summer storms can have lower percentiles than ambient winter flows.

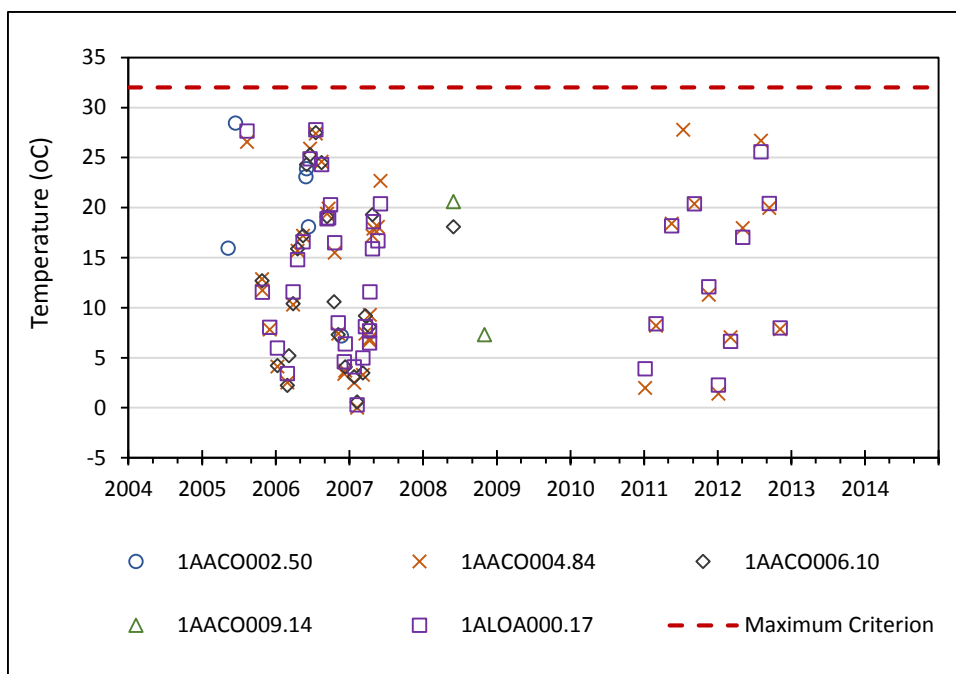
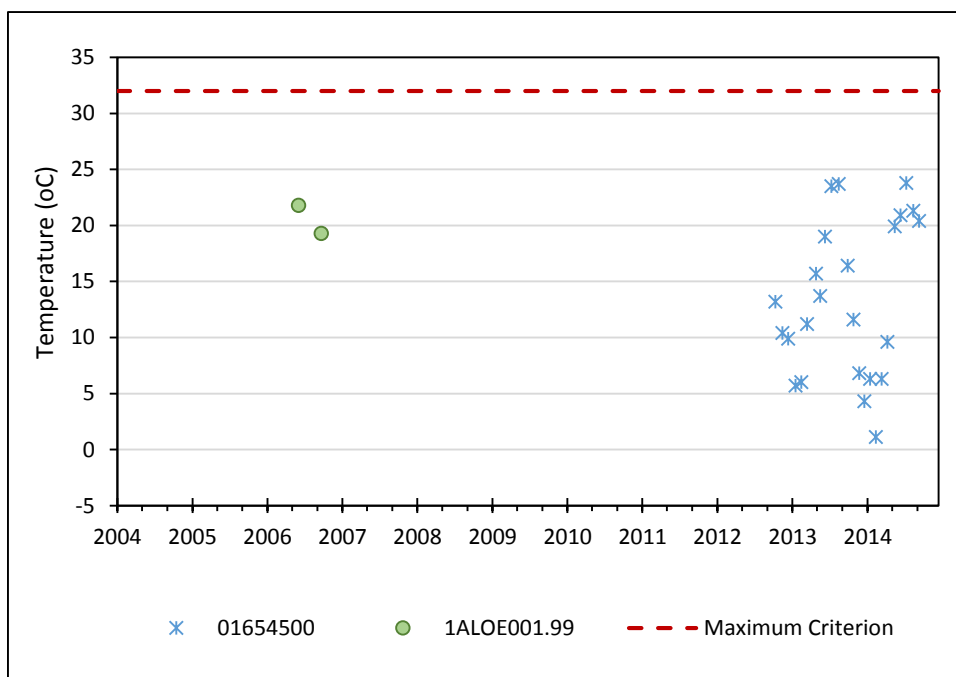
Water temperature measurements are made in the field when water quality samples are collected. **Figures 3-14, 3-15, and 3-16** show the temperature measurements of the samples from upper Accotink Creek, lower Accotink Creek, and Long Branch, respectively. Virginia water quality standards for Class III waters specify that water temperature should not be greater than 32°C (9VAC-25-260-50). No discrete sample in Accotink Creek exceeded this criterion.

**Figure 3-14: Observed Temperature (°C) in Upper Accotink Creek**

**Figure 3-15: Observed Temperature (°C) in Lower Accotink Creek**

**Figure 3-16: Observed Temperature (°C) in Long Branch**
