# **ANACOSTIA TRASH TMDL-RELATED BASELINE CONDITIONS MONITORING IN MONTGOMERY AND PRINCE GEORGE'S COUNTY**

**Prepared by  
Jan Ducnuigeen  
Interstate Commission on the Potomac River Basin**

**The Metropolitan Washington Council of Governments**

**ICPRB Report Number: ICPRB-09-02**

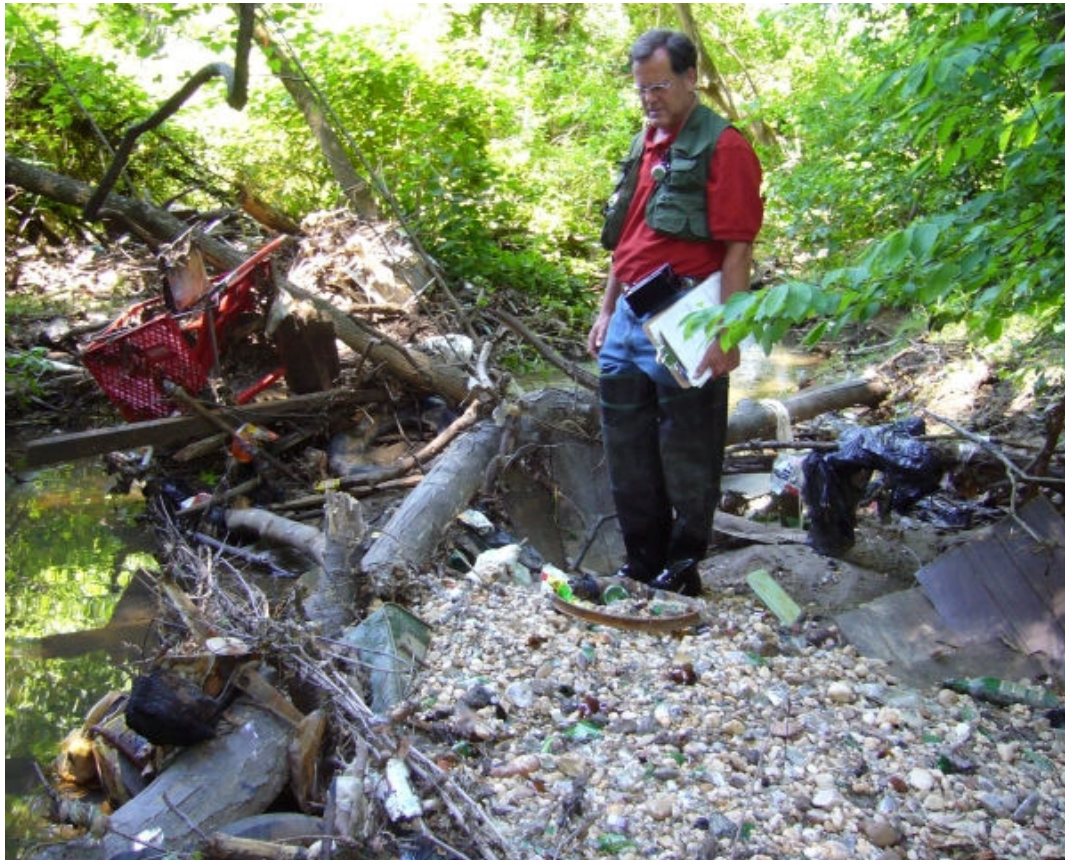
Cover photo: Dense stream trash in Watts Branch at Bugler Street

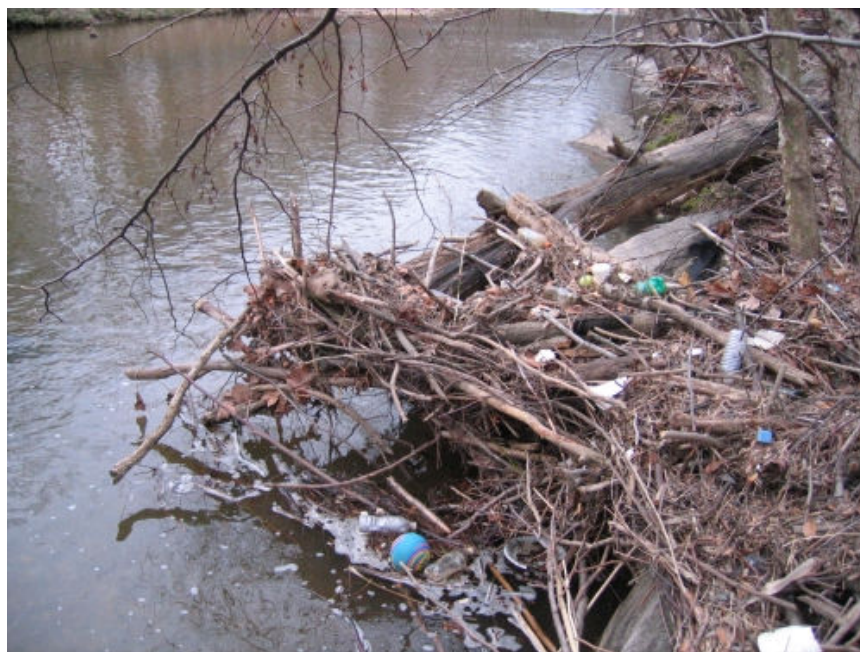
Figure 2. An example of a stream strainer, or in-stream obstruction which traps pieces of trash. obstruction that would cause the trapping of trash items, and usually consisting of fallen trees, branches

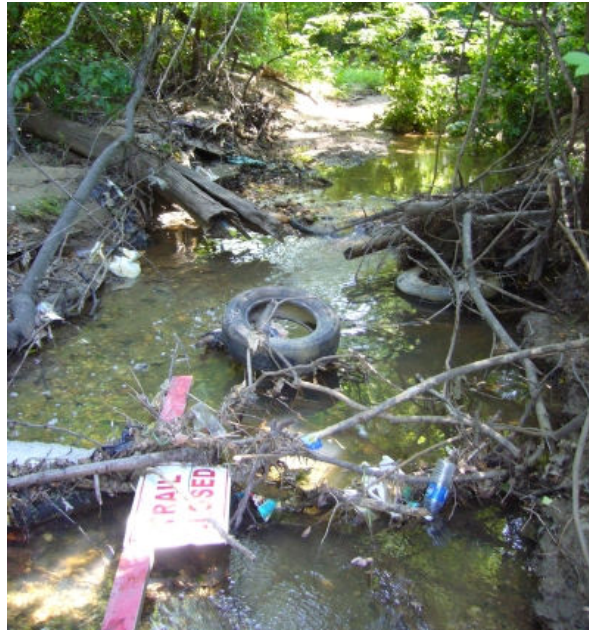
22-003: Stream channel before riparian changes

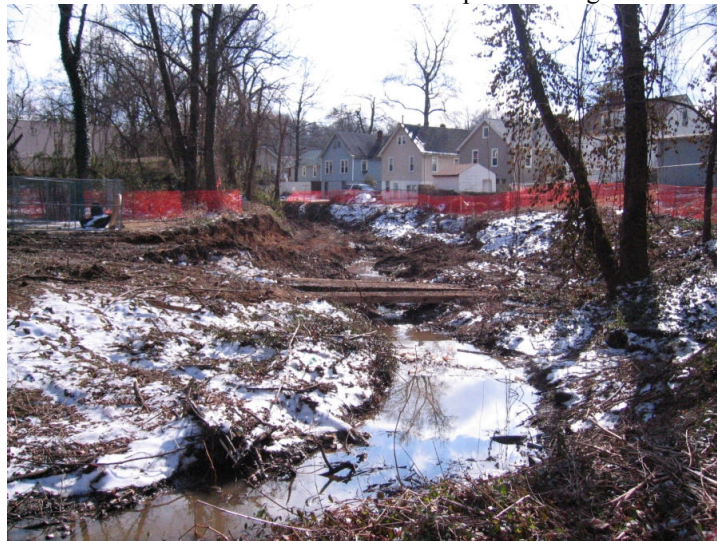
22-003: Stream channel during riparian reconstruction

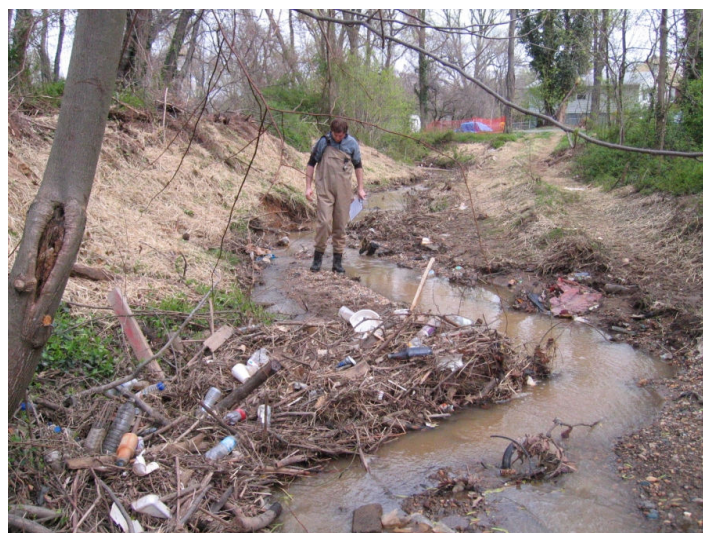
22-003: Stream channel after riparian reconstruction

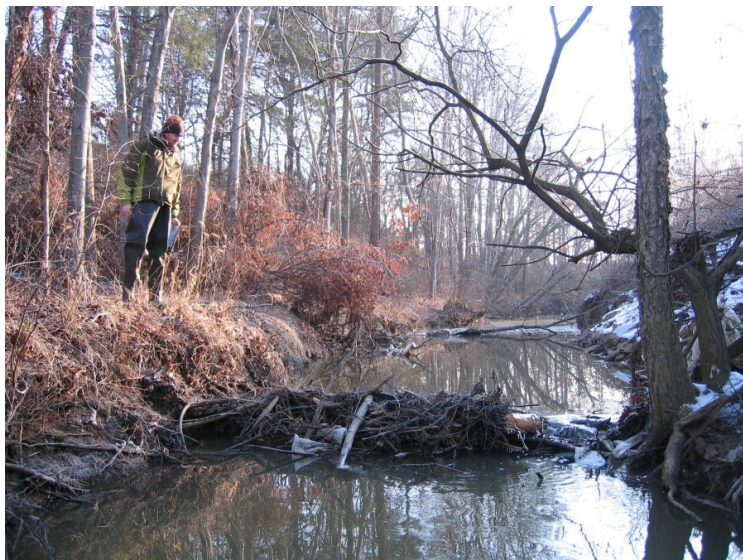
19-040A: Evidence of beaverdam construction in the lower section of survey reach.

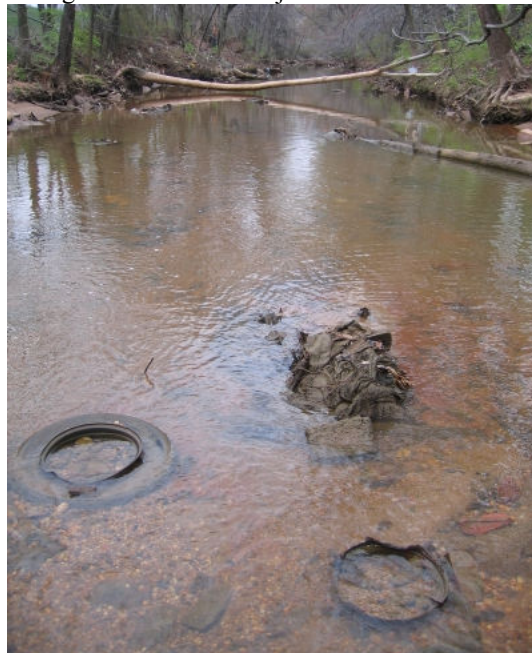
19-003: View looking downstream at submerged tires, car parts and car seats and cloth.

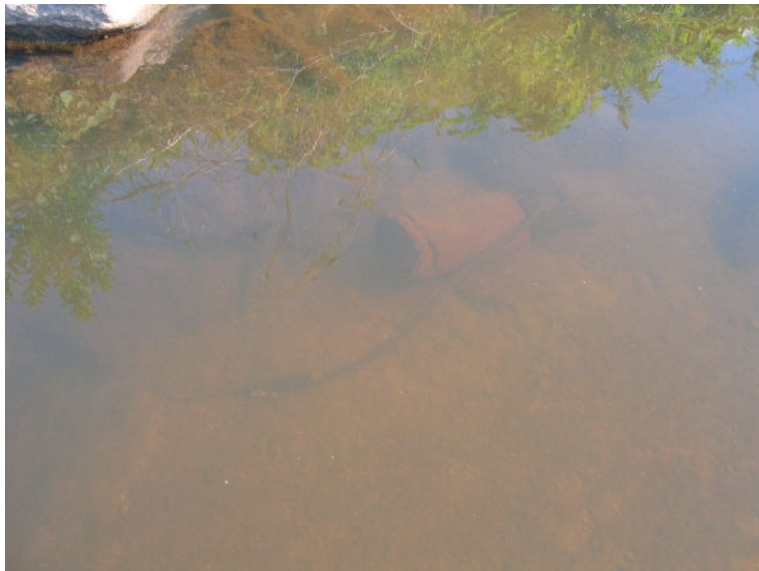
20-004: Discarded pesticide sprayer in the water

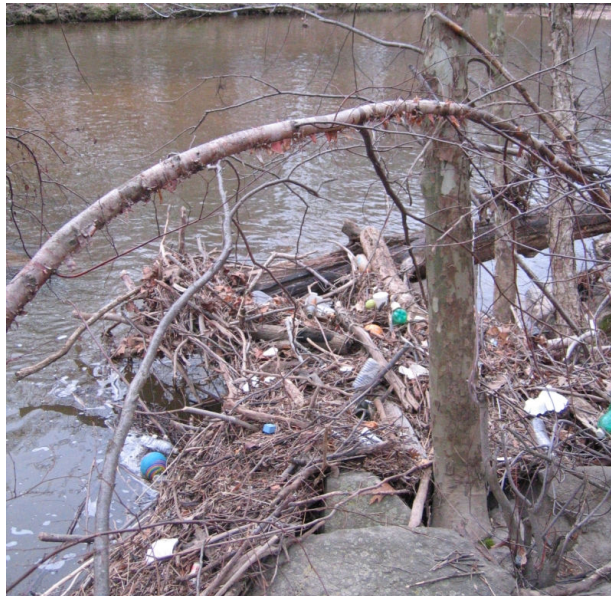
15-006: View of trash strainer

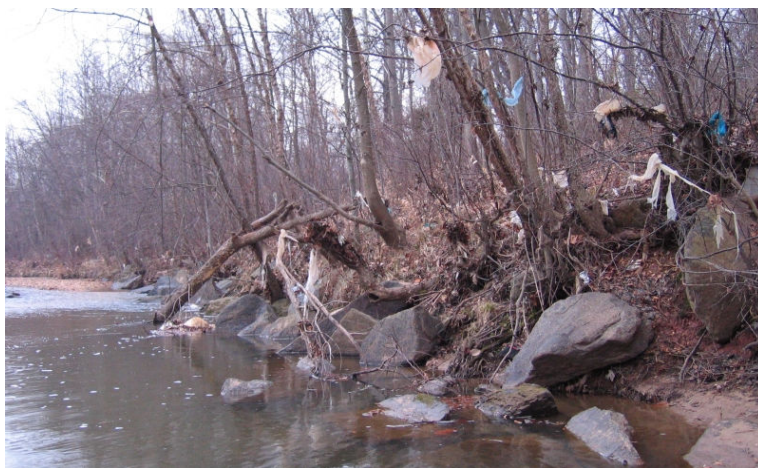
15-006: View of plastic bags trapped on trees during high water flows

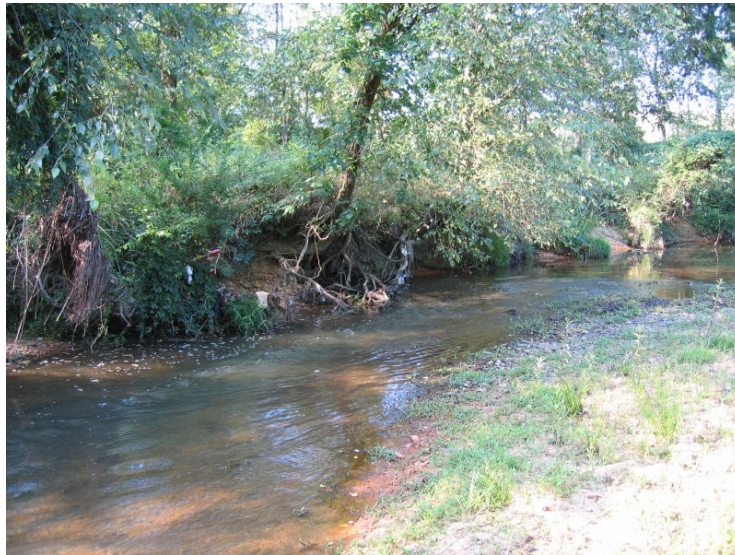
07-008B: View looking at trash on bank in middle of survey reach

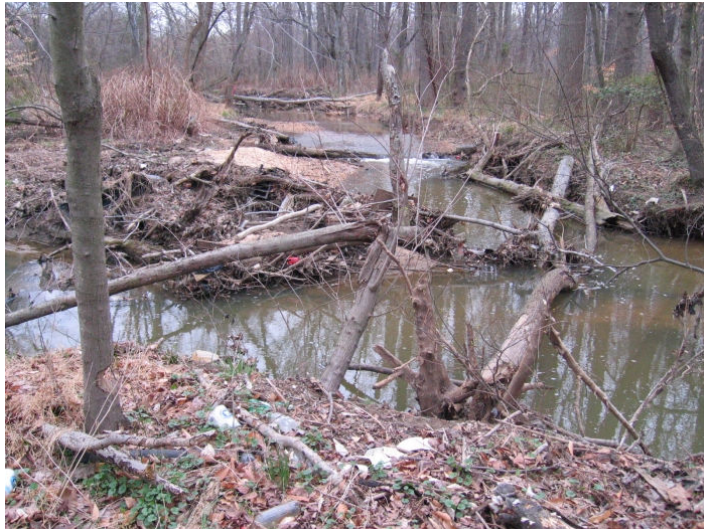
07-038: Log jam of trash and bank trash deposits looking upstream toward upper survey limit

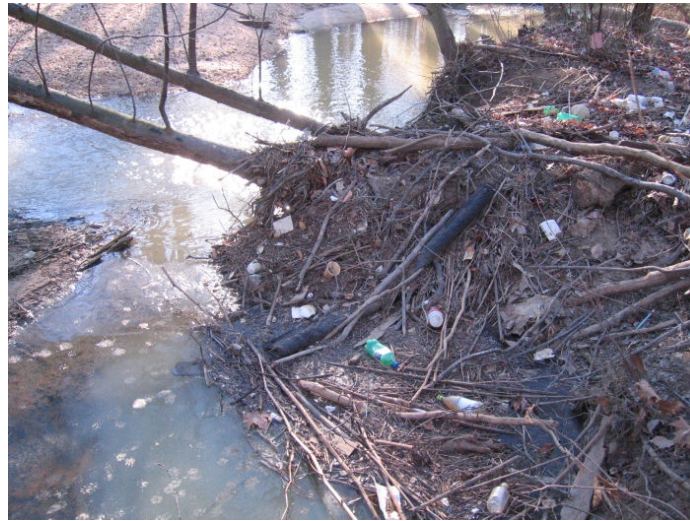
07-038: Trash accumulating in strainer in the middle portion of the survey reach.

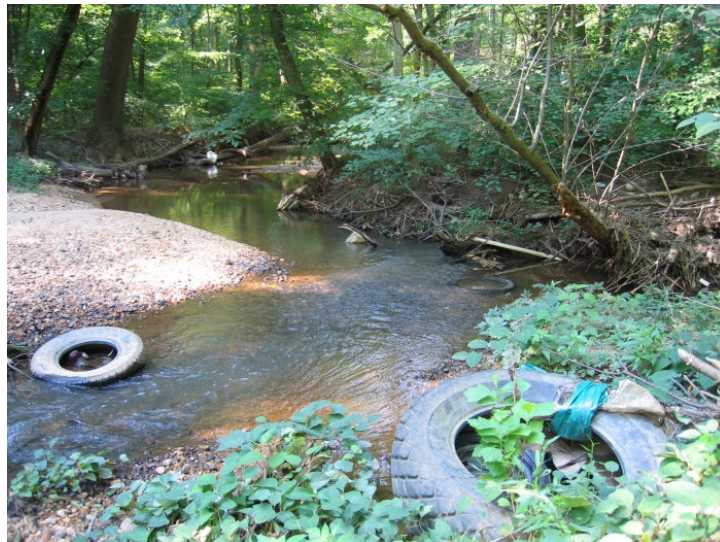
07-038: Large truck tires spread out within the survey reach

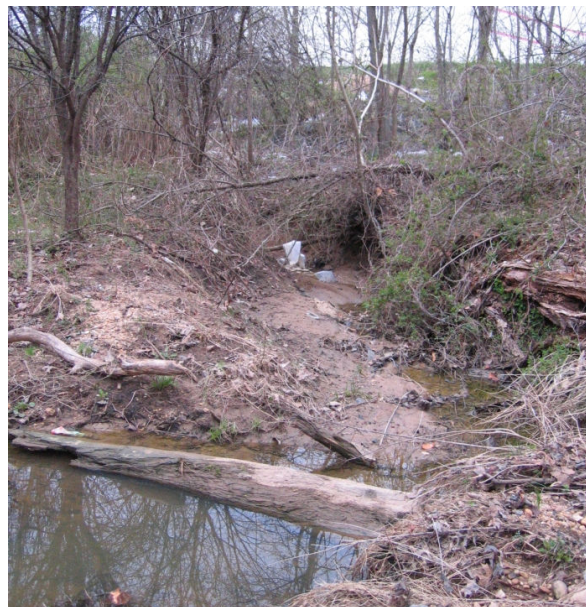
07-033: View of side channel tributary which appears to provide large amounts of trash into the main stream channel.

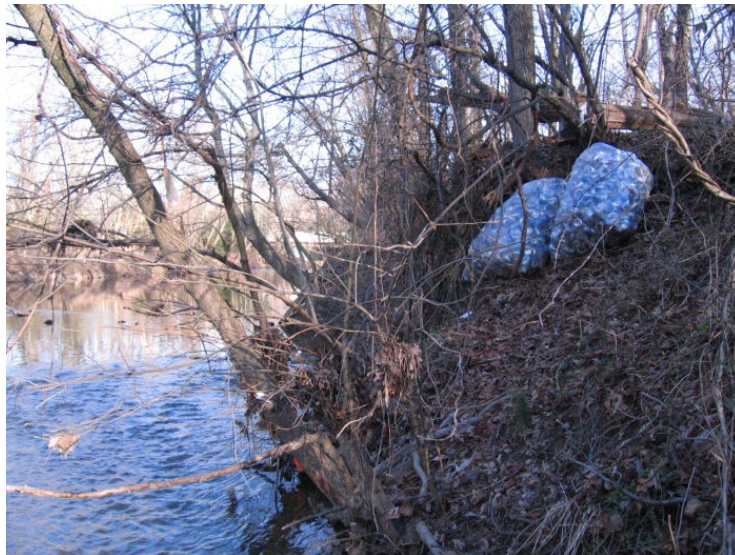
05-001: View of spring '09 deliberate dumping of beer cans.

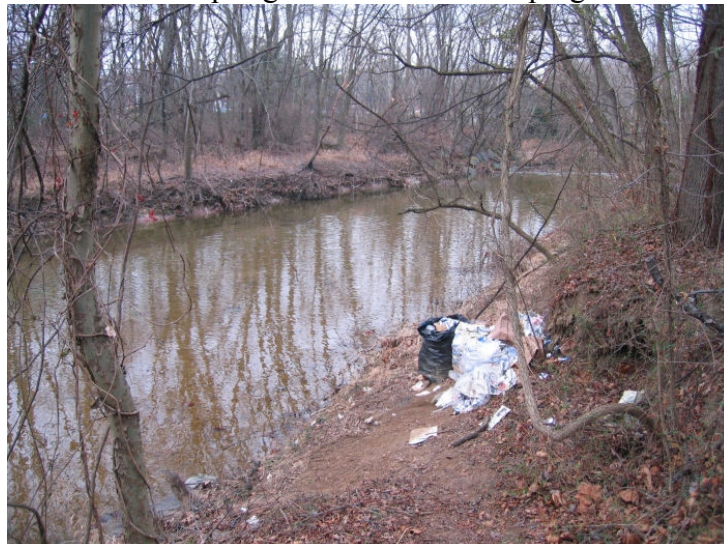
05-001: View of winter '08/'09 dumping of beer cans and newspapers

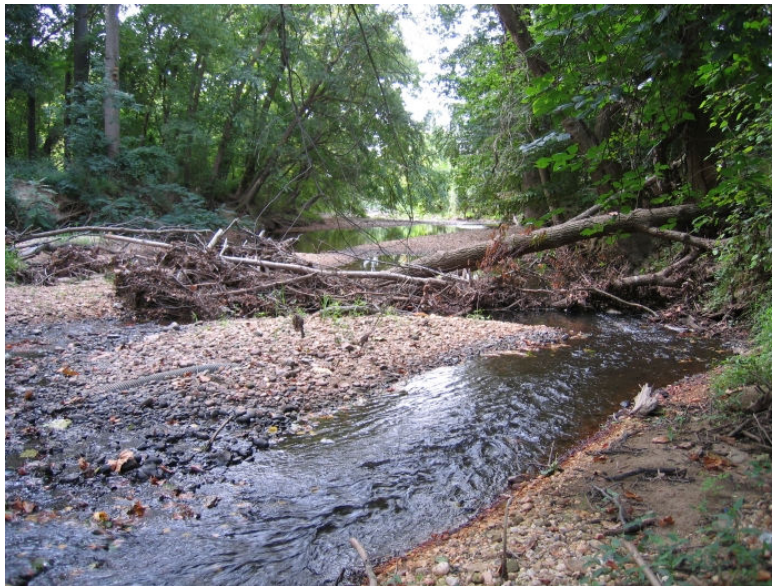
05-004: View of large strainer looking downstream from middle of survey reach limit

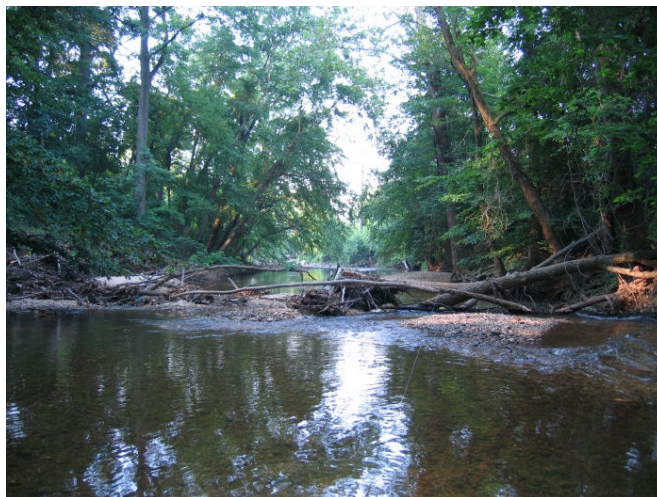
05-004: View of large strainer looking downstream

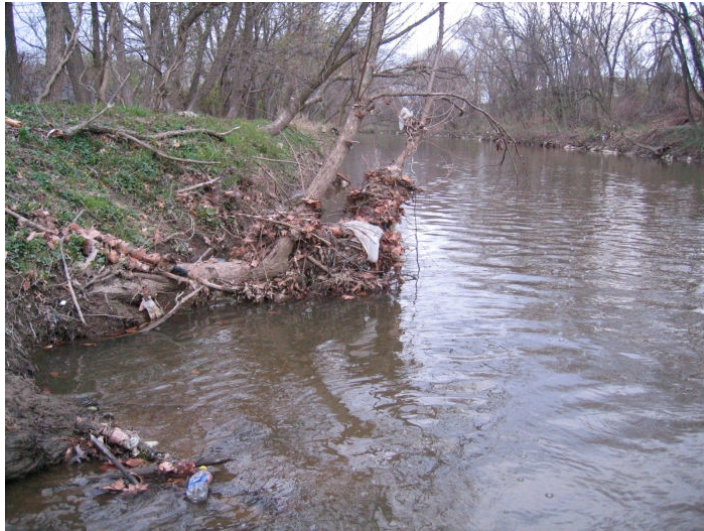
09-006: View of trash strainers

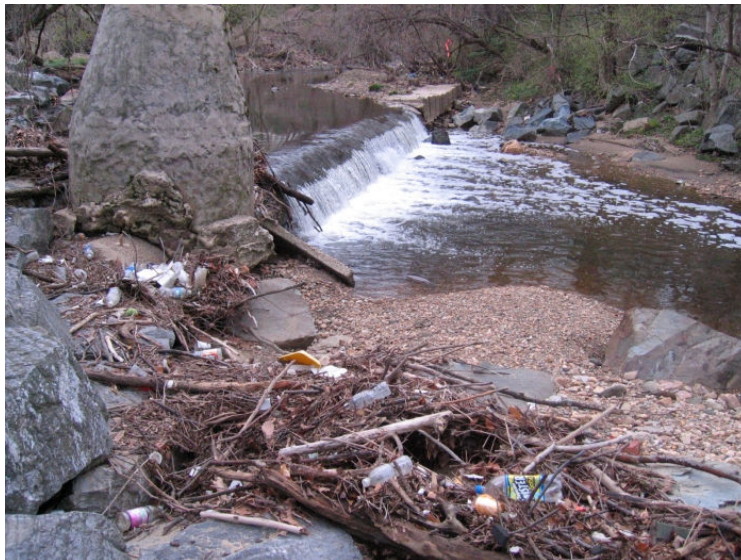
14-001: View looking upstream at trash debris in upper portion of survey reach

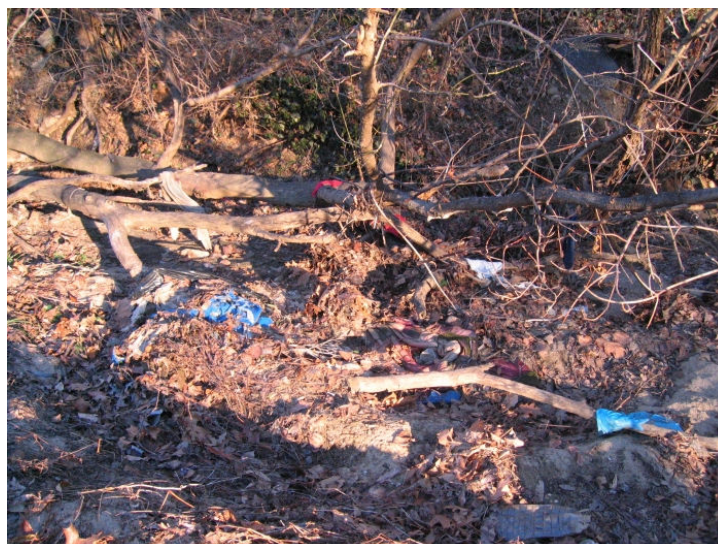
14-001: View of cloth and plastic bag trash deposited during high flows

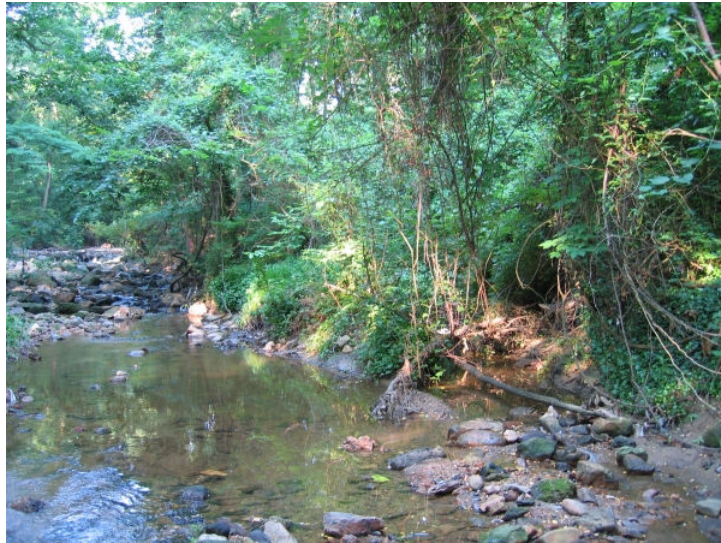
14-002A: View looking upstream near upper survey reach limit. Small tributary enters from the right supplies additional trash to the main channel.

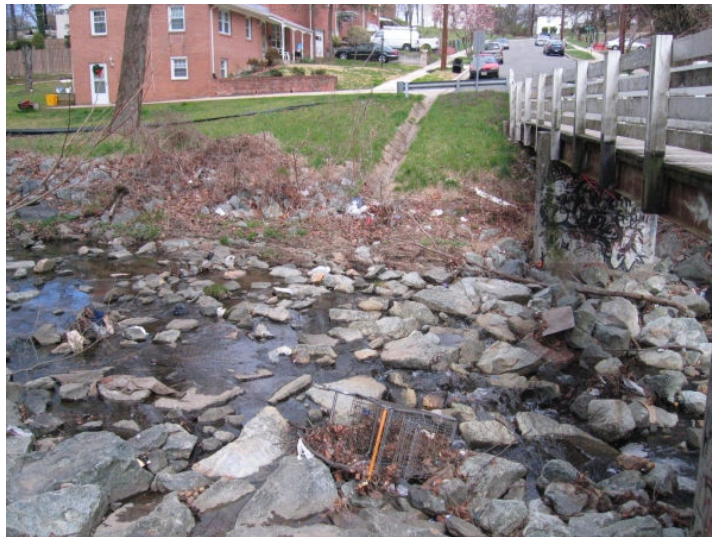
14-002A: View of lower limit of the survey reach at the pedestrian bridge. Considerable trash is deposited from the bridge above.

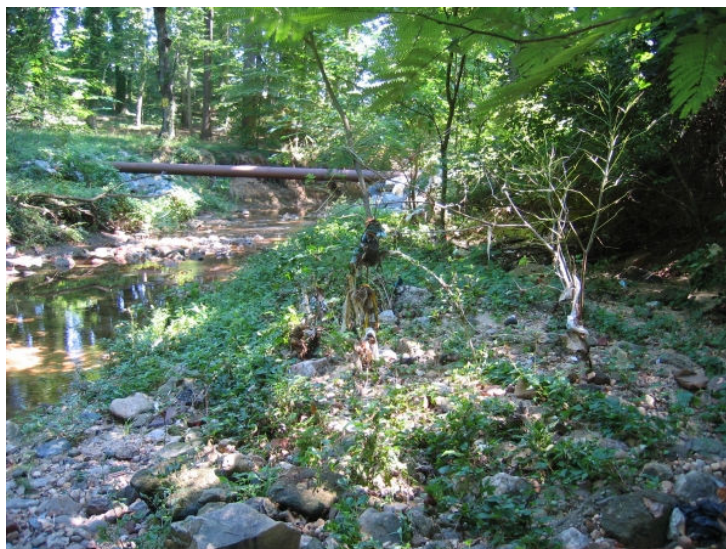
14-002A: View looking down stream at trash on trees and exposed pipe crossing stream

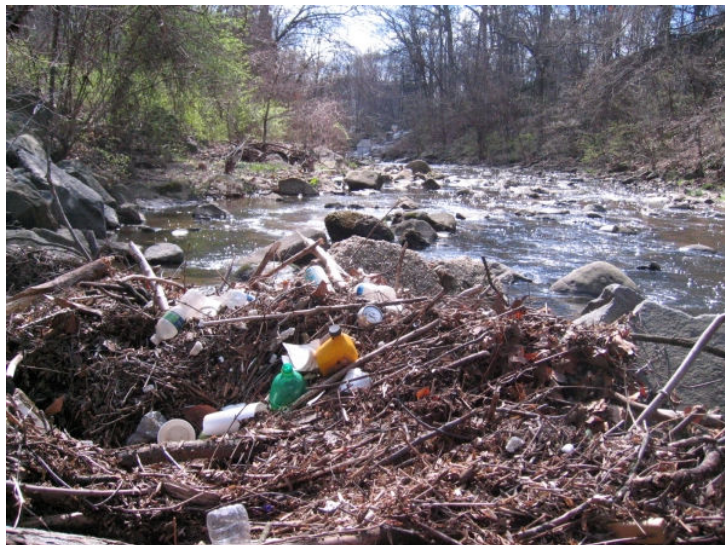
SCSC314: Looking downstream at trash strainer in middle of survey reach

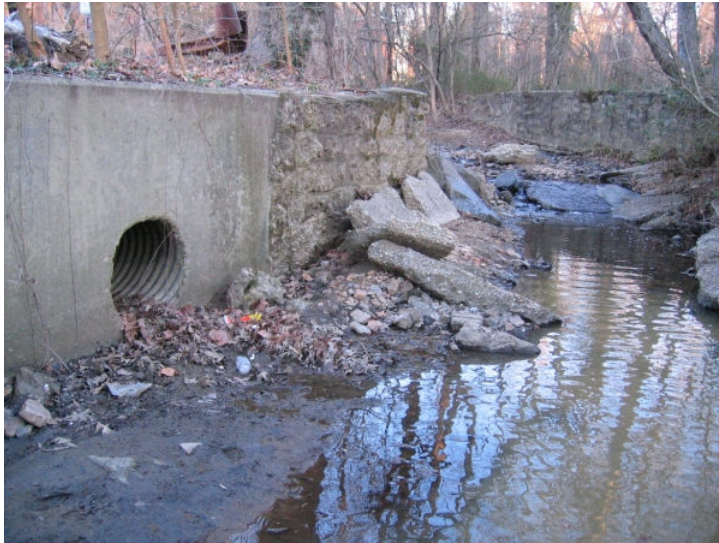
SCLB101: View looking upstream from middle of survey reach. Street culvert enters stream channel on the left, a point of trash entry to the main stem of Long Branch.

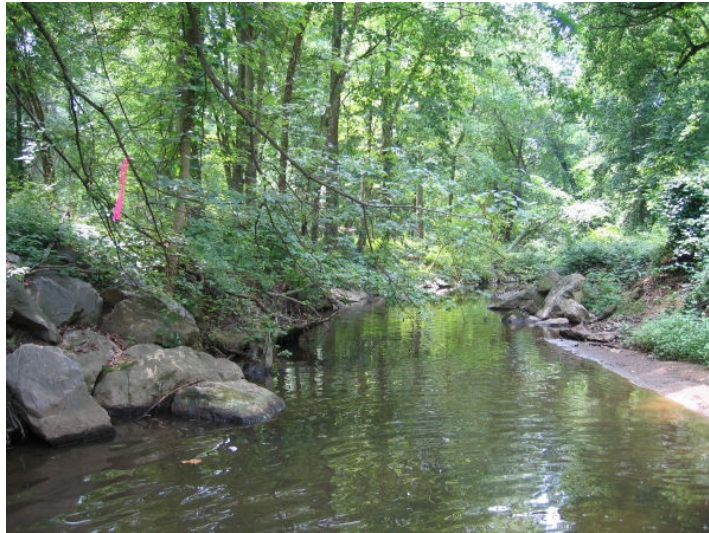
SCSC301: View looking downstream from upper survey reach limit. A large pipe draining the roadway enters the stream on left in this photo

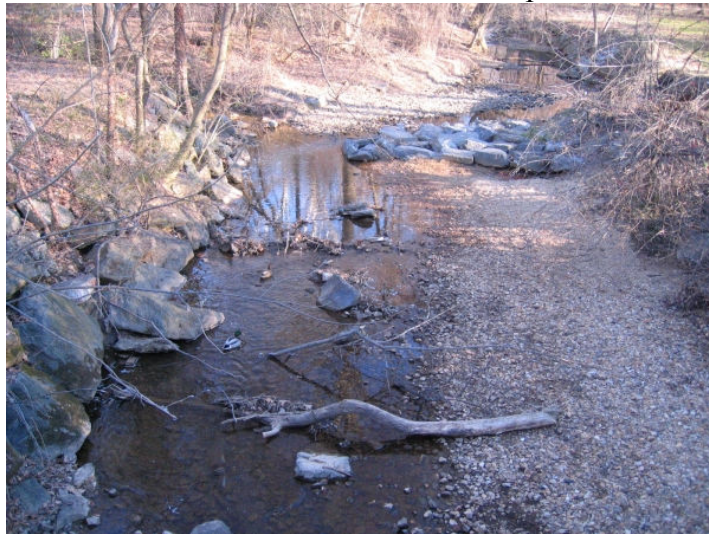
SCSC301: View looking upstream from pedestrian bridge at lower limit of survey reach. A small tributary draining a residential area enters from the left in the photo.

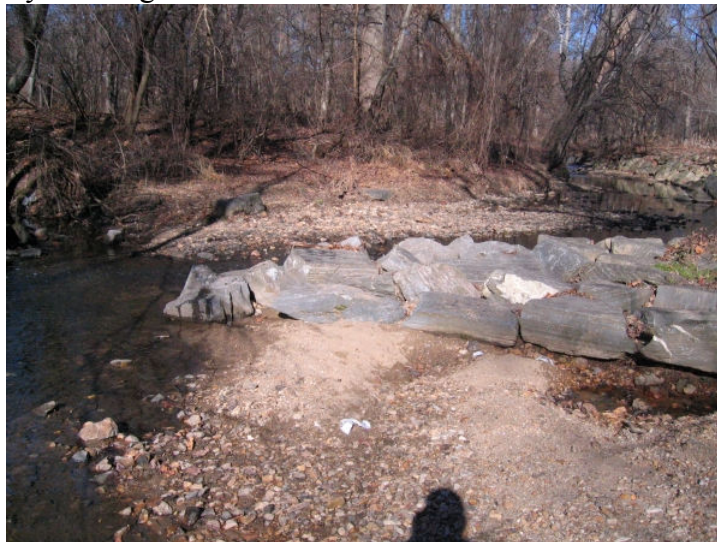
SCSC301: View looking upstream from rock stream wing deflector, which has trapped some styrofoam trash.

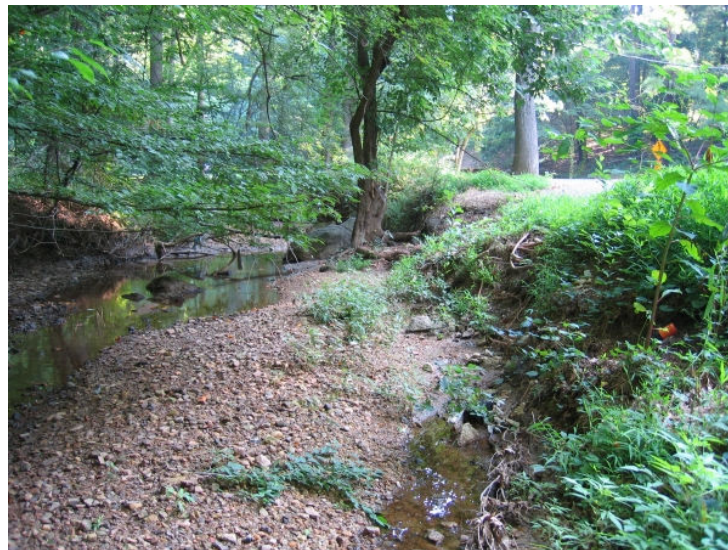
SCSC204: View looking upstream at area next to road pull-off area on Sligo Creek Parkway. Orange oil filter can be seen in right portion of photo, likely tossed from pull-off area.

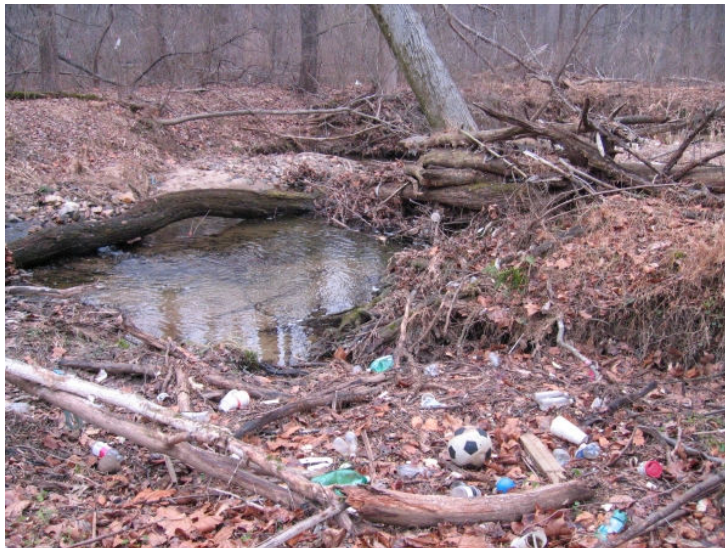
PBHB210: View looking downstream at trash strainer and bank trash deposits

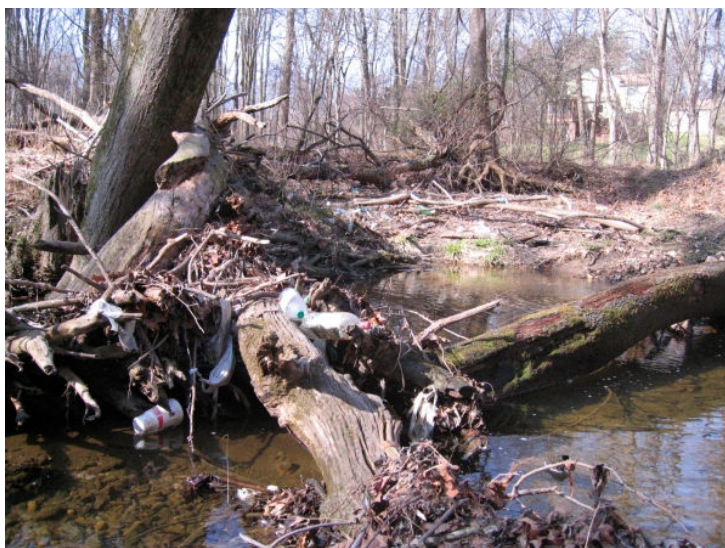
PBHB210: View looking upstream at trash strainer

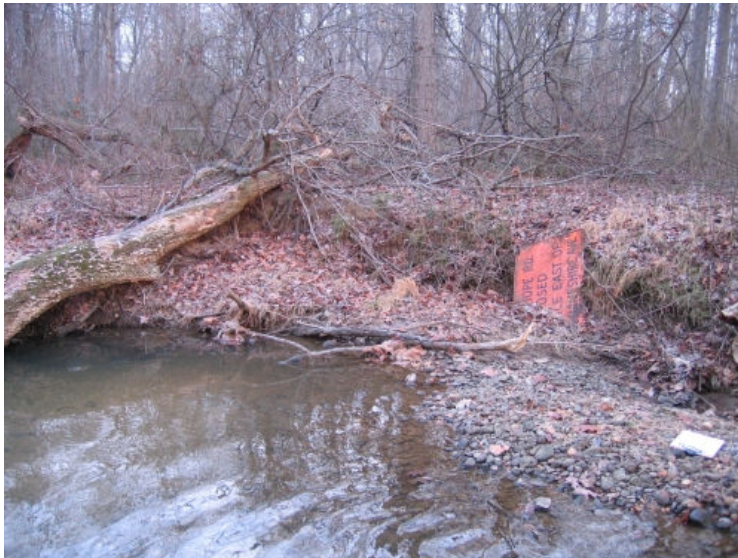
LPLP202: View of trash debris embedded into the stream bank

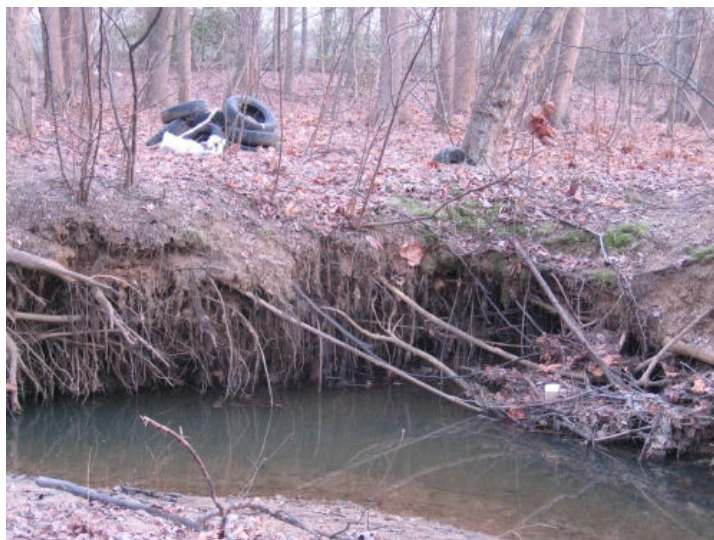
LPLP202: View of trash strainer, and tire pile (not included in trash count due to it's location above bank full level).

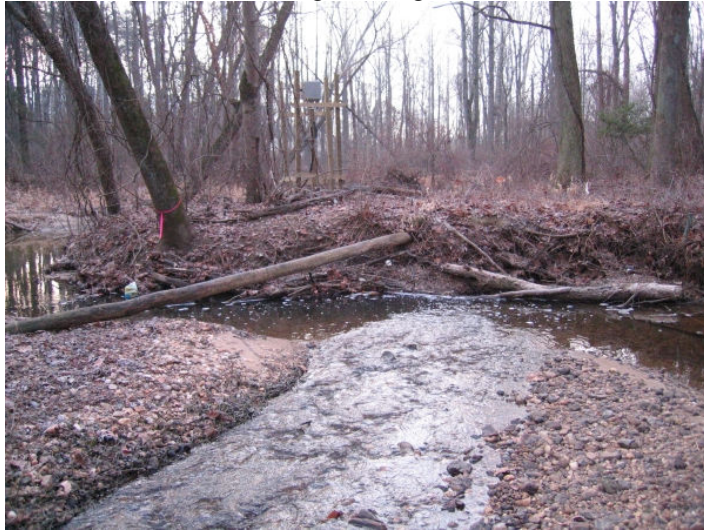
LPLP205: View looking downstream at trash strainers at the lower limit of the survey reach (orange flag on tree) and confluence of the tributary surveyed and the mainstem Little Paint Branch (far left). Another stream monitoring station can be seen on the bank (center).

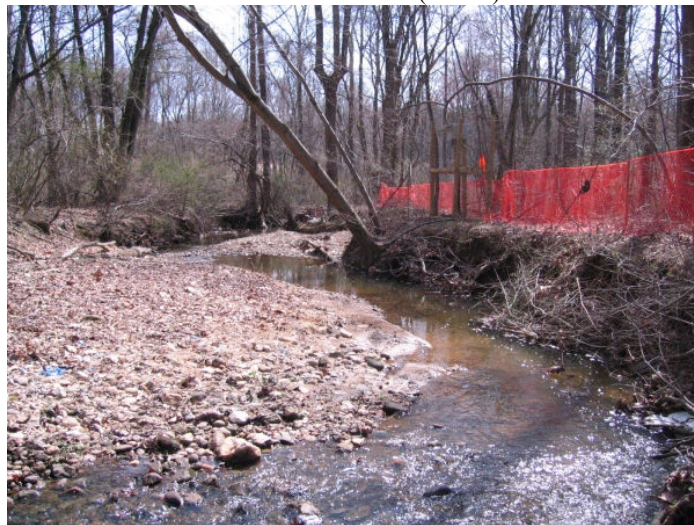
LPLP205: View looking downstream from the middle of the survey reach. Orange fencing from private landowner appears to be in preparation for land clearing along and through the stream.

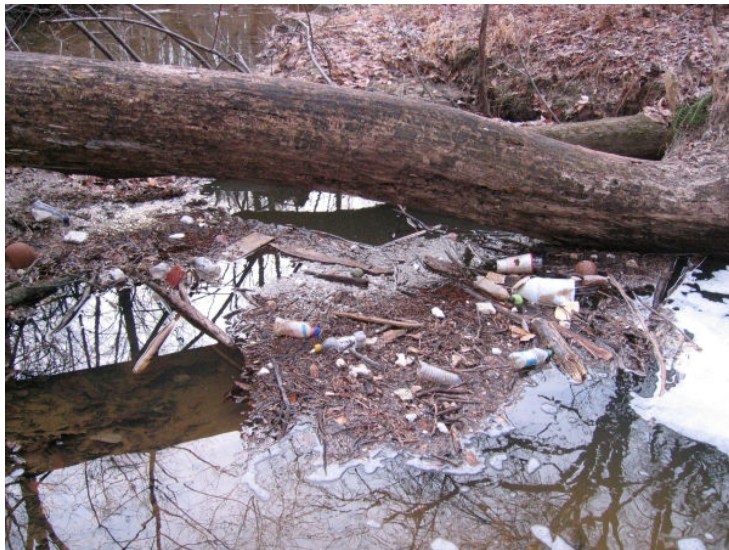
LPLP301A: View of trash strainer in middle of survey reach

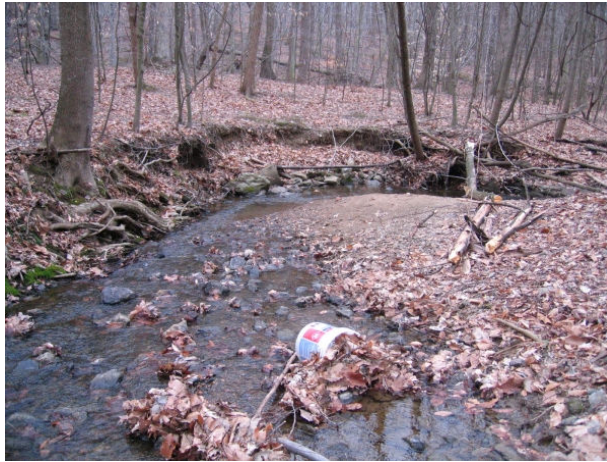
LPLP109: View looking downstream of residential home renovation trash

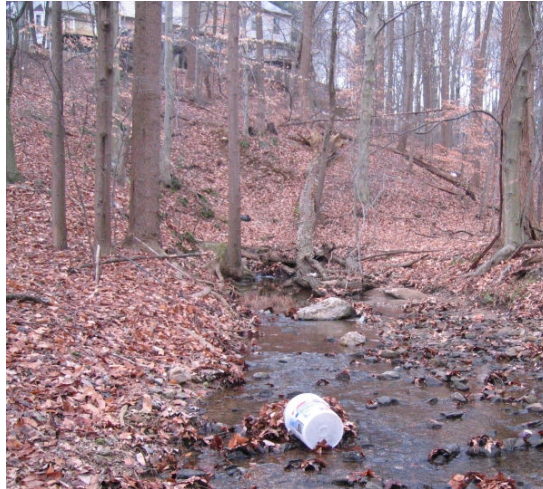
LPLP109: View looking upstream at residential homes whose owners have dumped household trash over fences and down to stream banks (black trash bag) in distance.

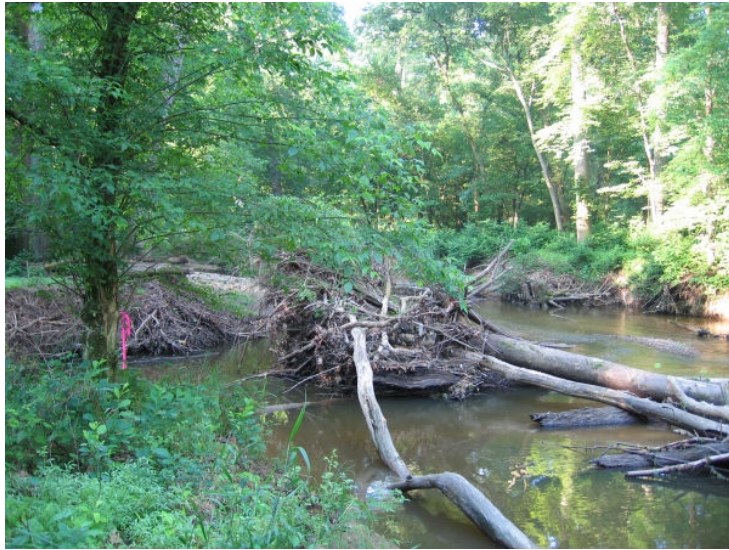
NWNW407D: View looking downstream at upper survey reach limit and large trash strainer

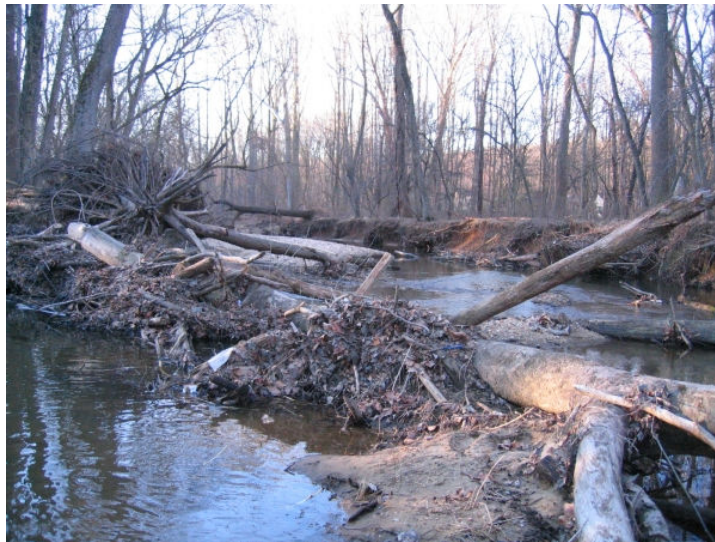
NWNW407D: View looking downstream at large trash strainer

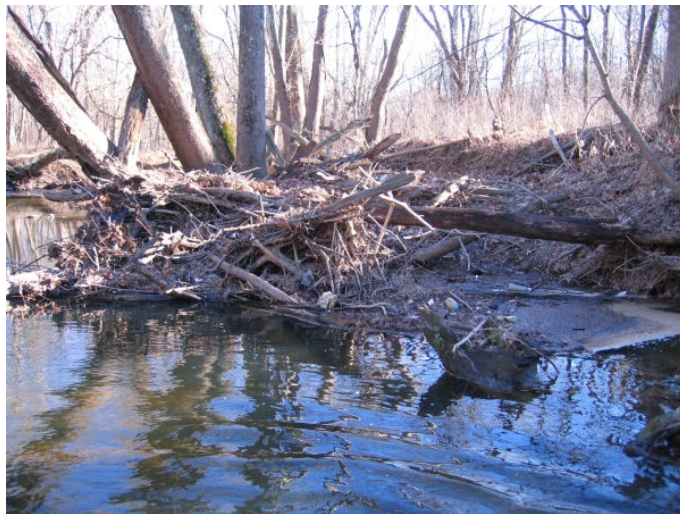
NWNW407D: View looking downstream at trash strainer

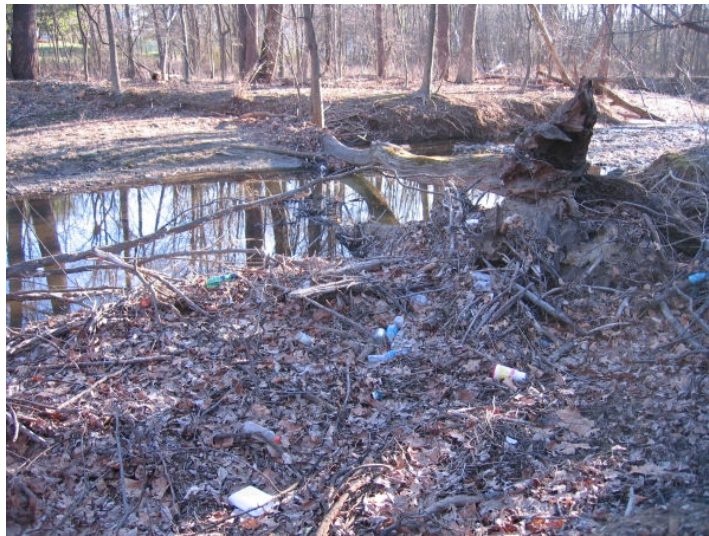
NWBP205: View of trash strainer and trash debris

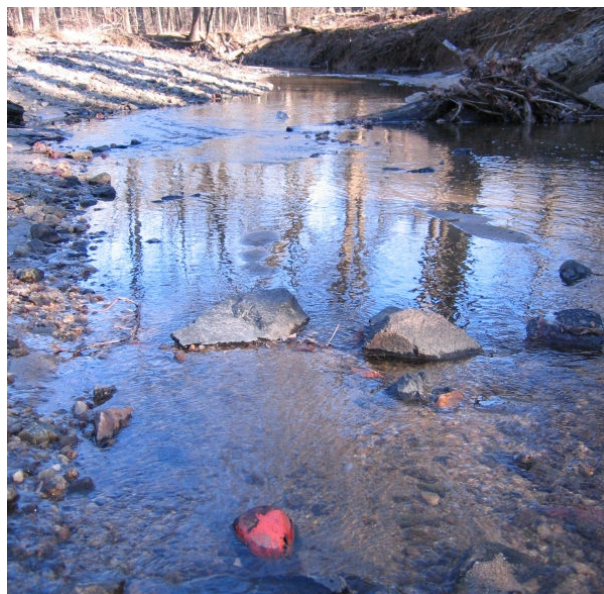
NWBP205: View of orange oil filter in stream channel

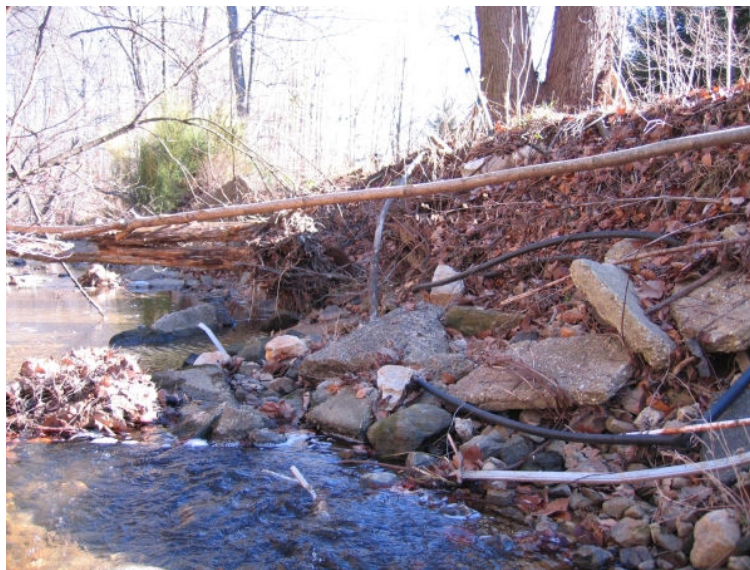
NWBP301: View looking downstream at trash and landfill construction debris

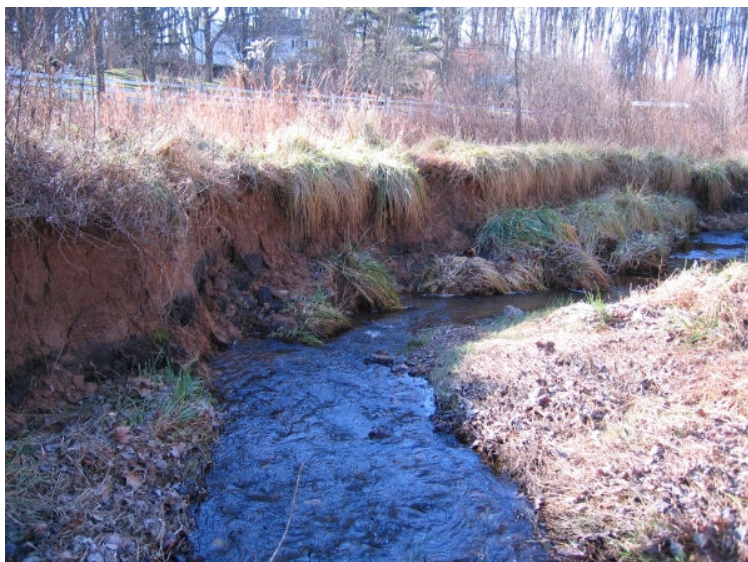
NWNW206A: View looking downstream at unstable bank structure
